**PACKER ENGINEERING INC,**  
1950 North Washington Street,  
Naperville, IL 60566

**Metallurgical Evaluation of a Nurse Tank Cracked Head**

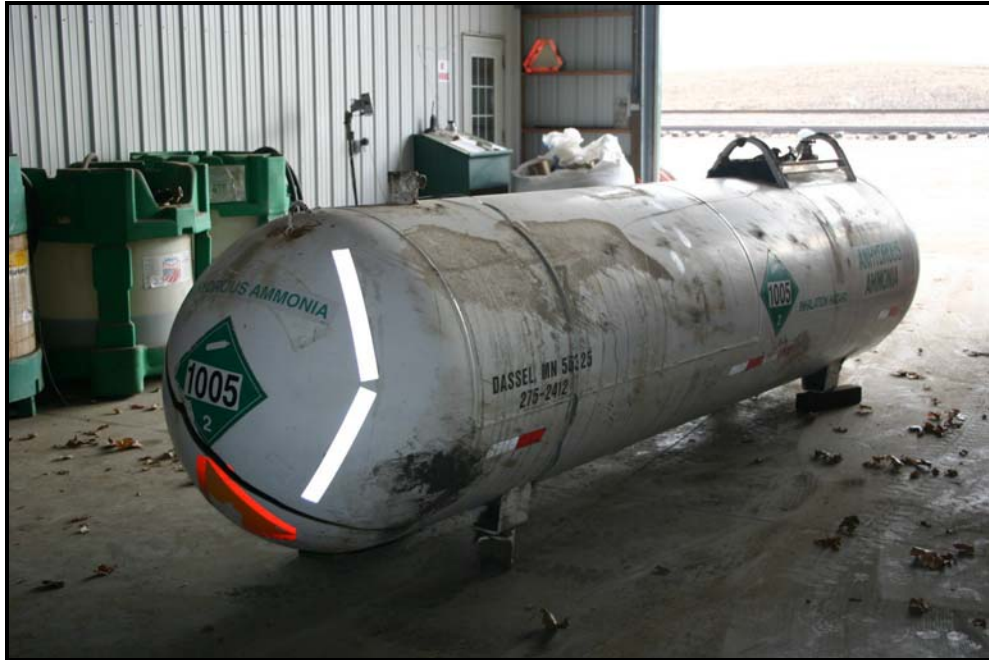
**Figure 1: The subject nurse tank in storage after the rupture.**

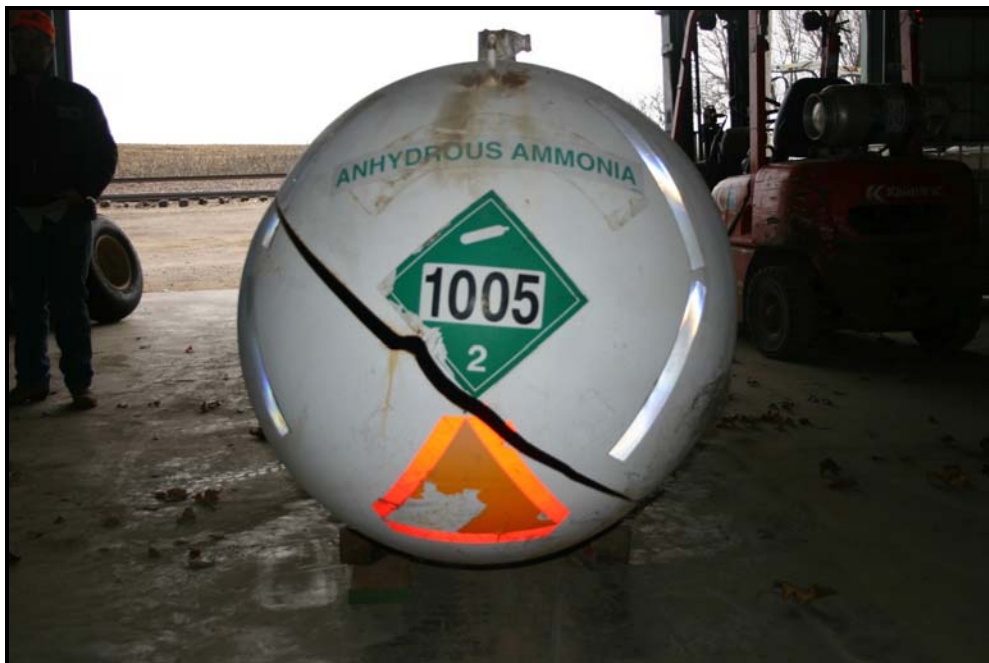
**Figure 2: The tank head received by Packer Engineering. The label indicates that it is used to transport anhydrous ammonia.**

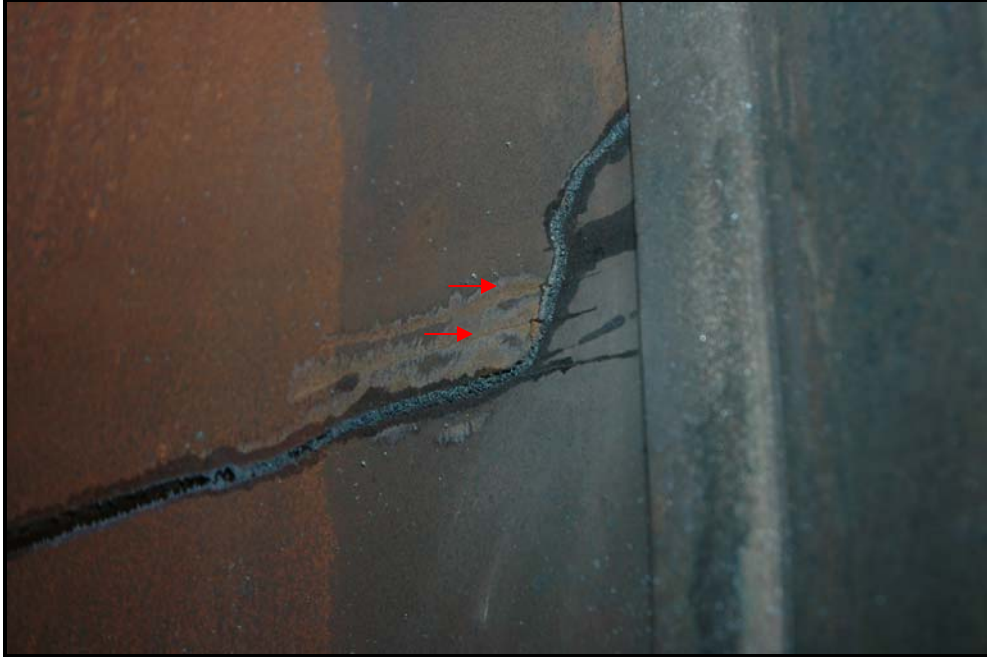
**Figure 5: Two cracks (indicated by arrow) observed parallel to the fracture surface on the ID of the tank head.**

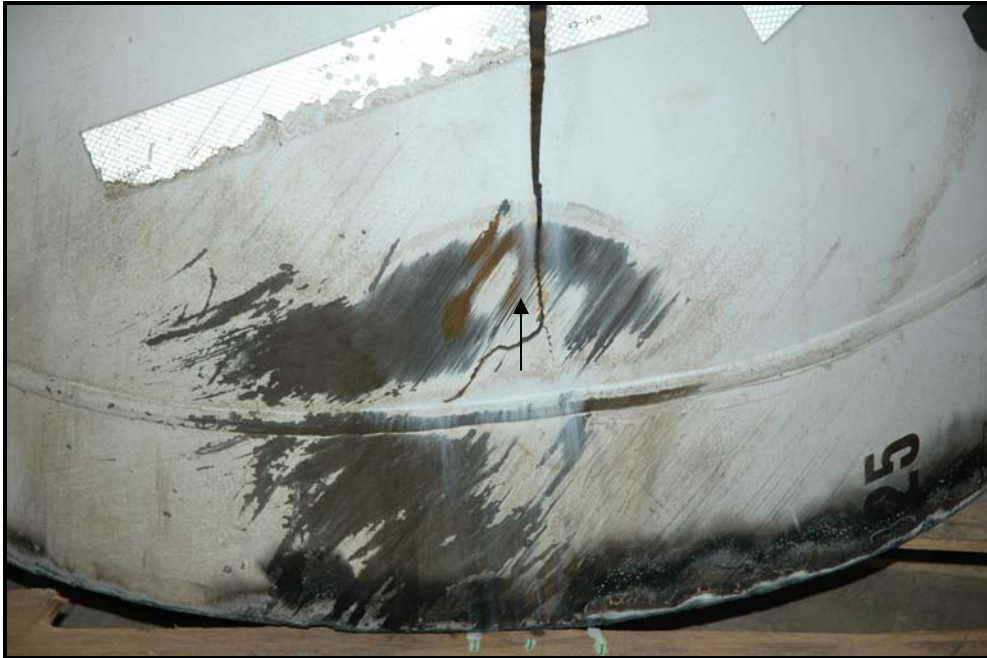
**Figure 6: Shows impact damage and peeling of paint on the tank head. Arrow indicates the location of the two cracks on the inside surface of the tank head.**

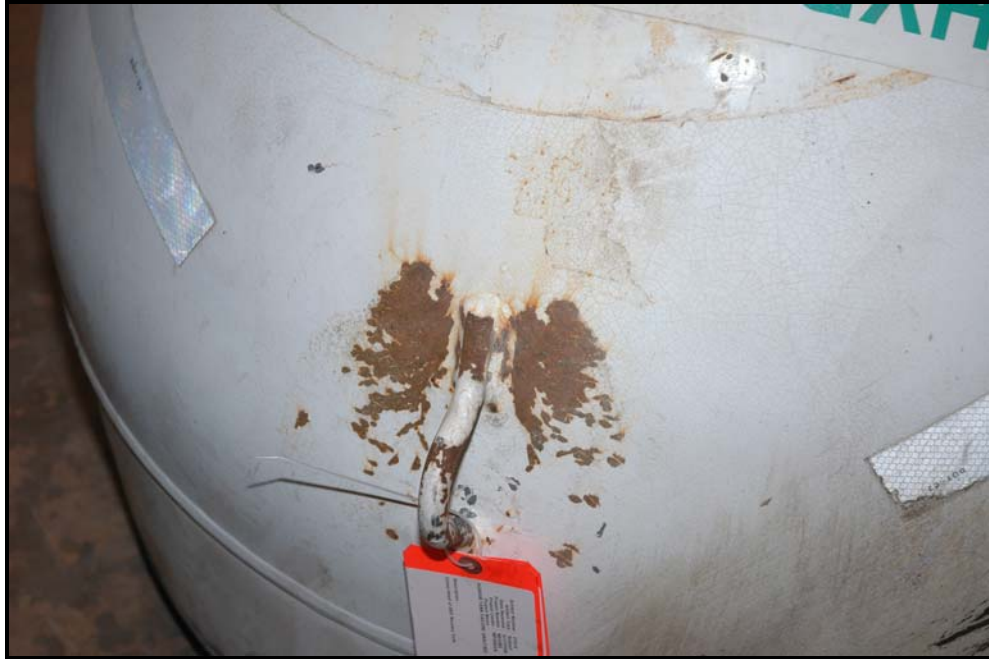
**Figure 7: Shows corrosion on the tank head.**

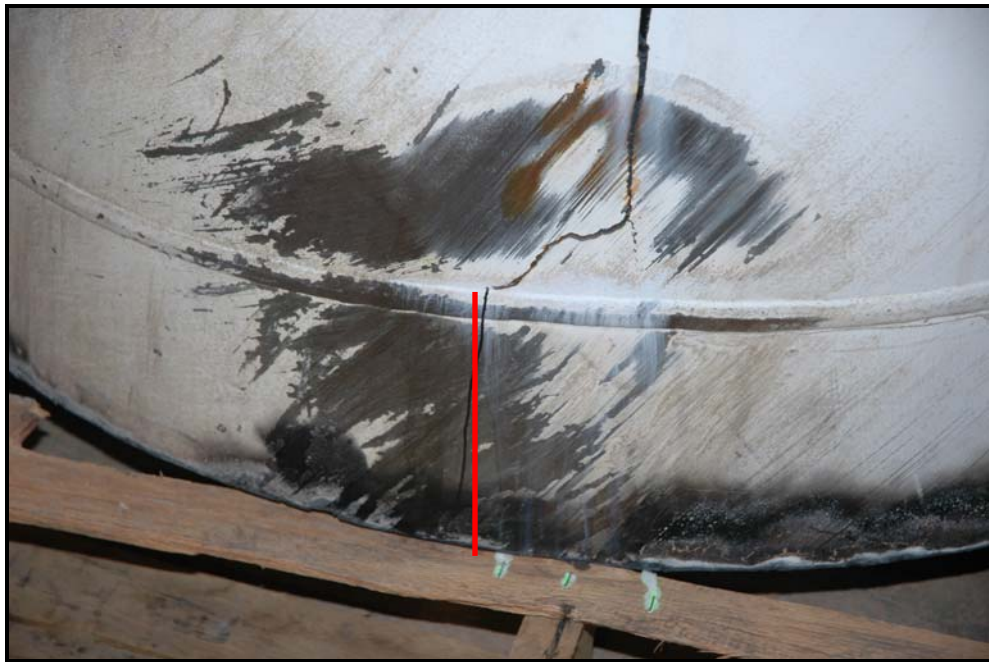
**Figure 8: Image shows where (red line) the tank was cut to expose the fracture surface.**

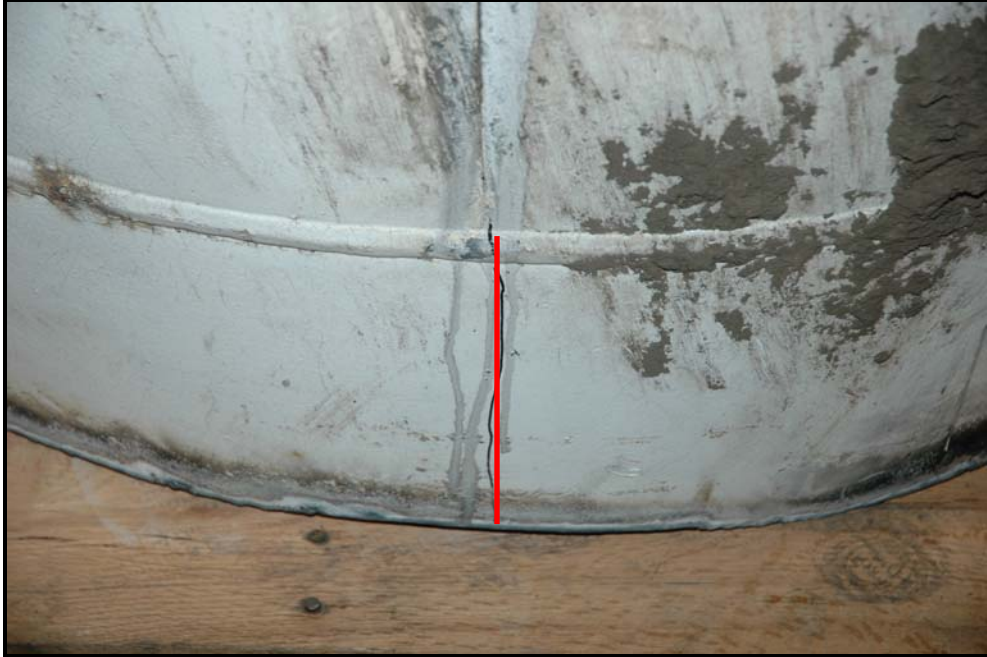
**Figure 9: Image shows where (red line) the tank was cut to expose the fracture surface.**

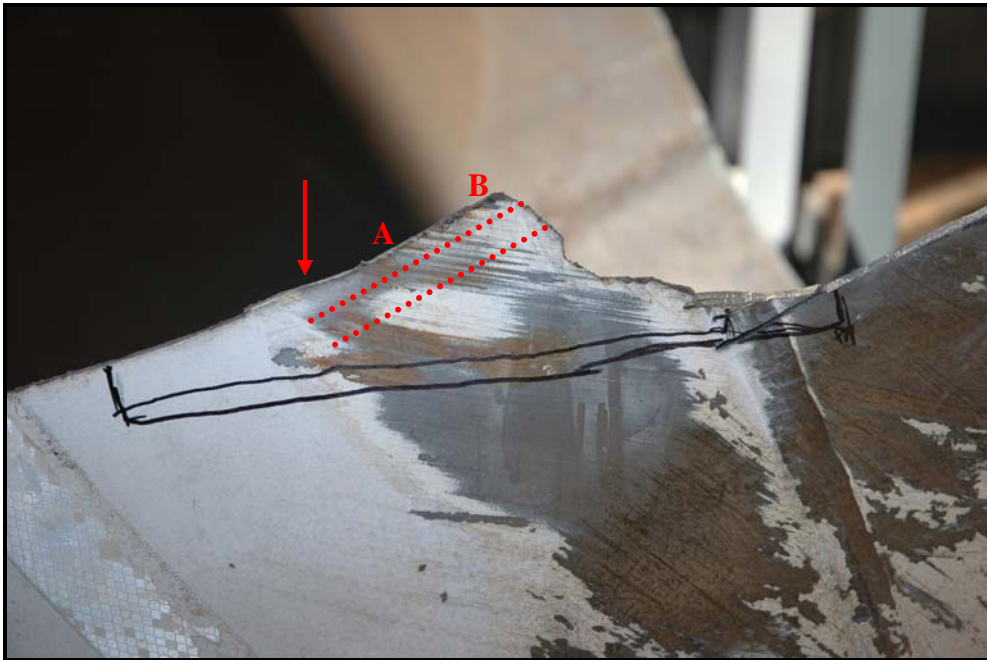
**Figure 10: Shows area on the tank head containing the origin of the fracture (as indicated by arrow). There were two cracks found on the ID of the tank head running parallel to the fracture surface near origin. These two cracks are illustrated by the red dotted lines.**

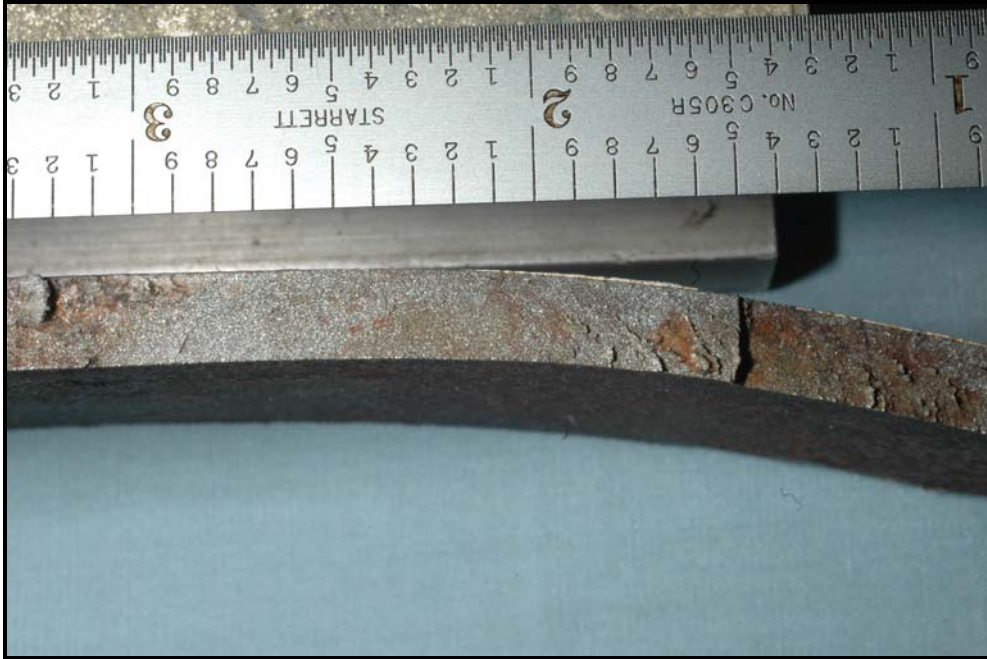
**Figure 11: Photograph of the fracture surface at the fracture origin. A small, faint clamshell pattern was observed at the fracture origin. The fracture surface appears to be brittle and faceted.**

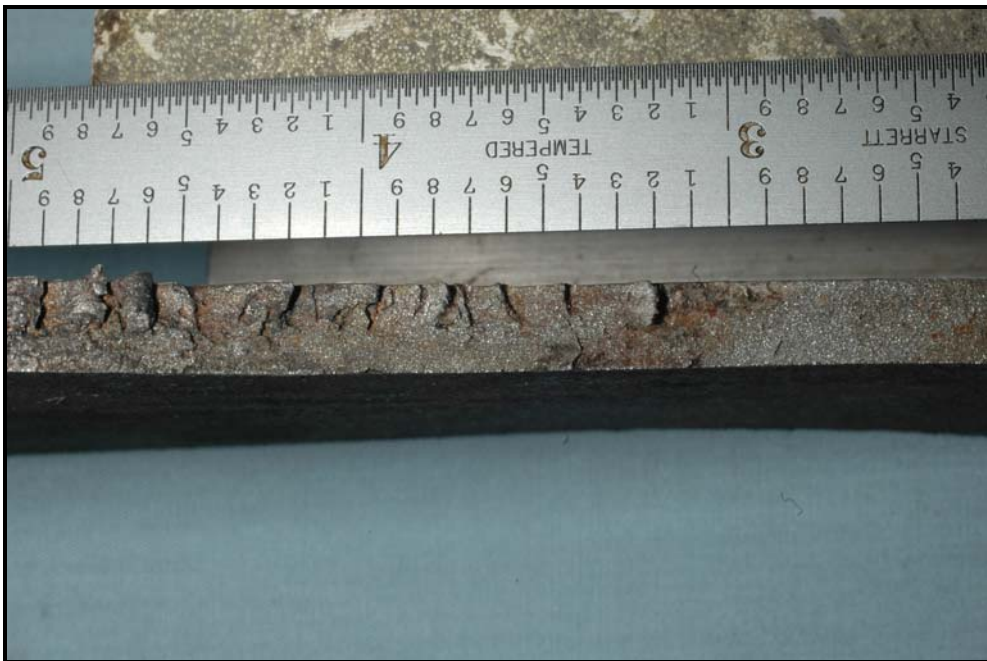
**Figure 12: Photograph of the fracture surface at location "A" identified in Figure 10.**

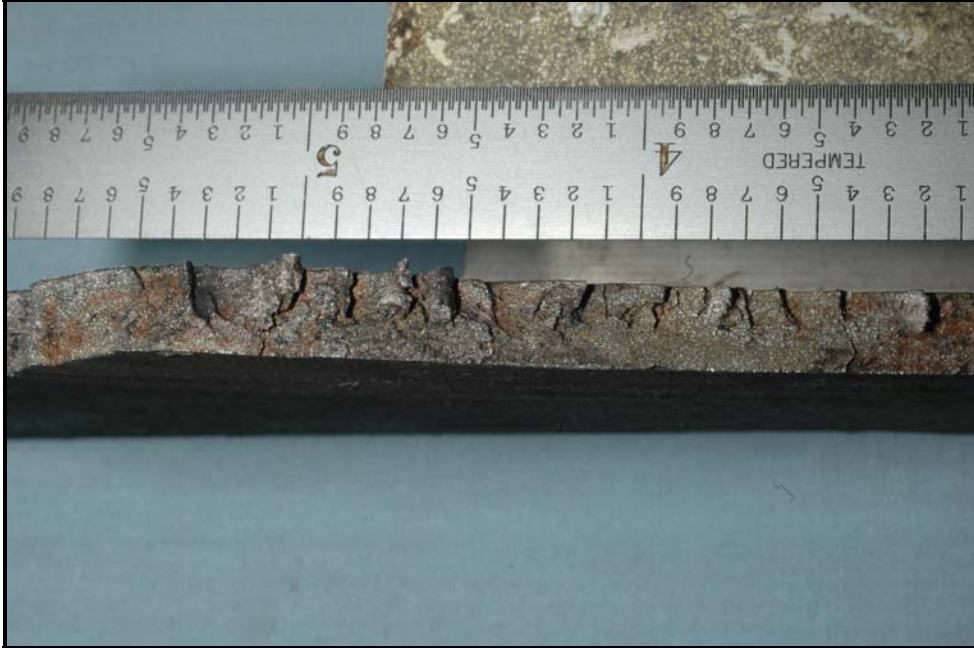
**Figure: 13 Photograph of the fracture surface at location “B” identified in Figure 10.**

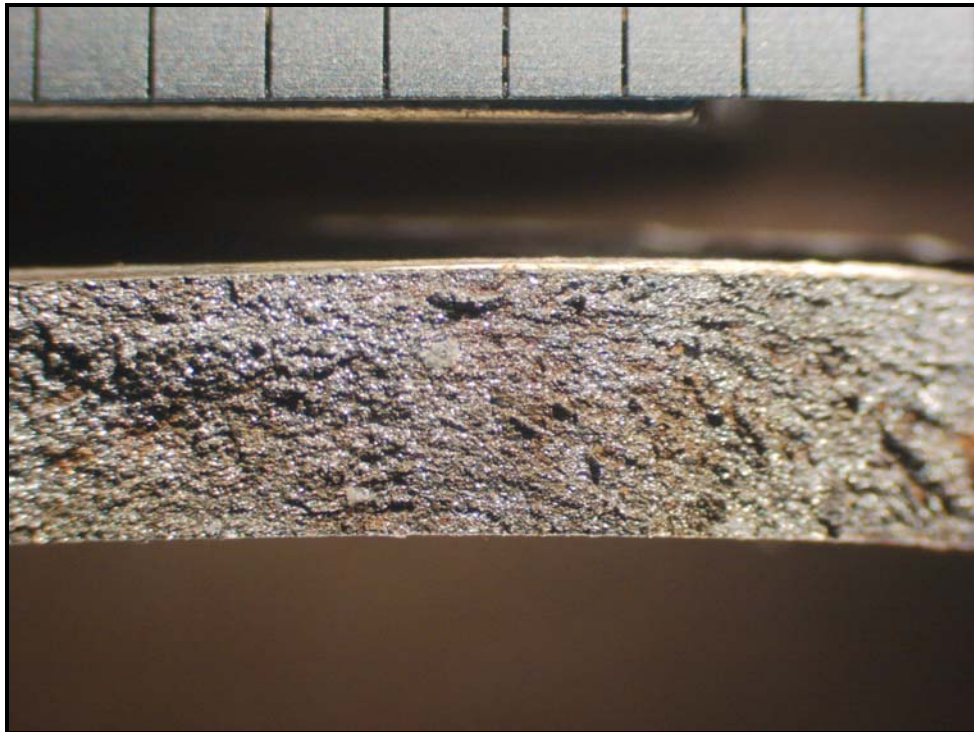
**Figure 14: Stereoscope image at the fracture origin. The fracture surface at the origin appeared flat and faceted. A faint clam shell pattern was also observed at the fracture origin.**

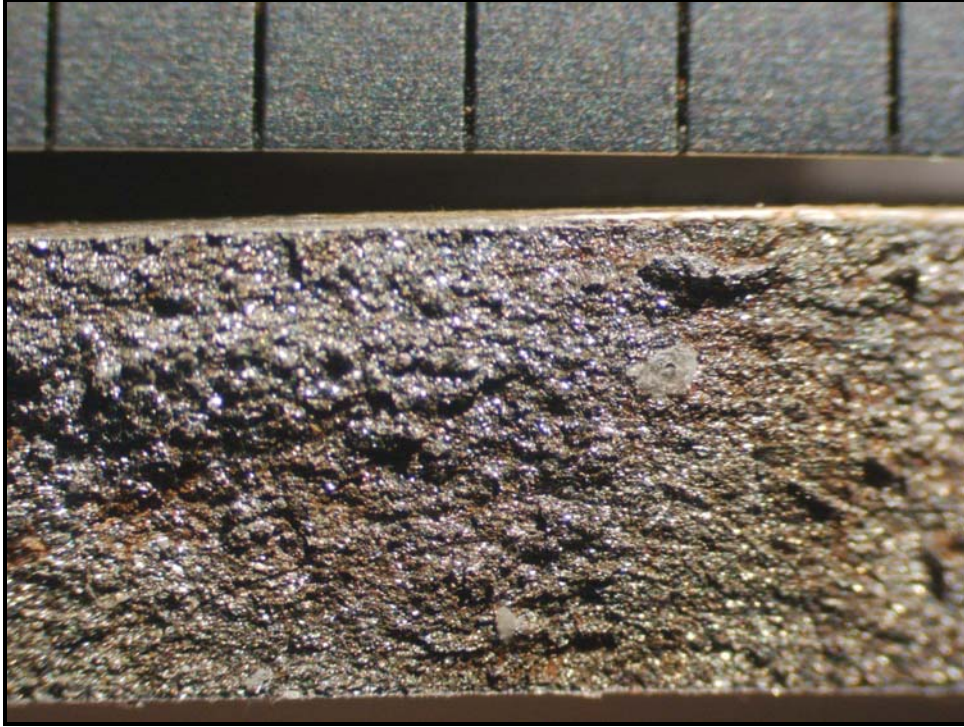
**Figure 15: Stereoscope image of the fracture origin at higher magnification.**

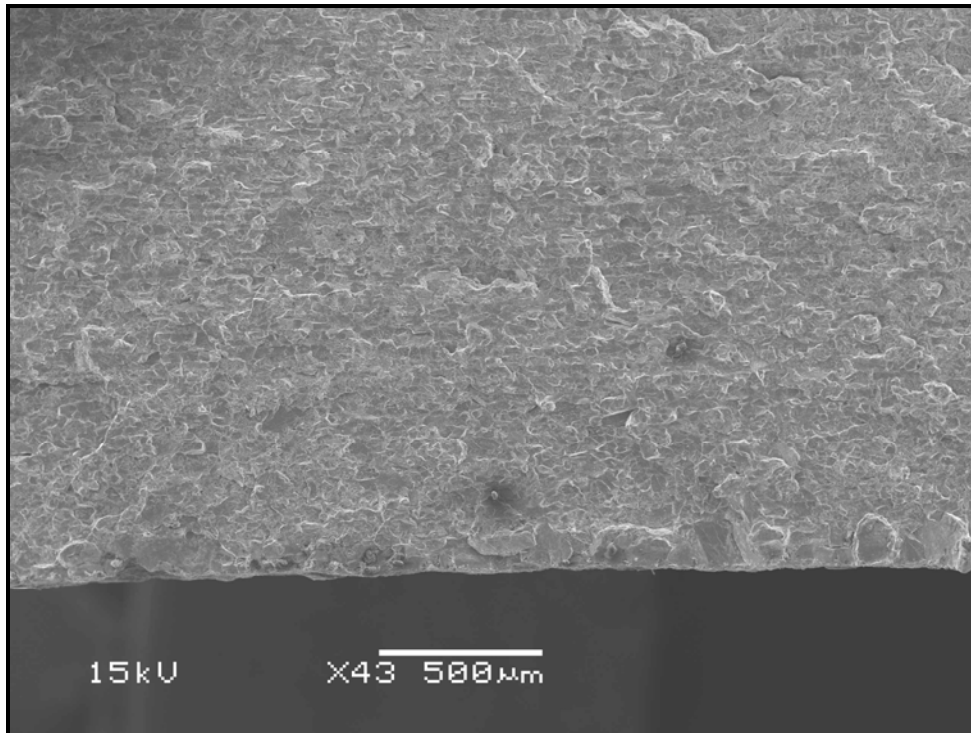
**Figure 16: SEM image of the fracture surface at the origin.**

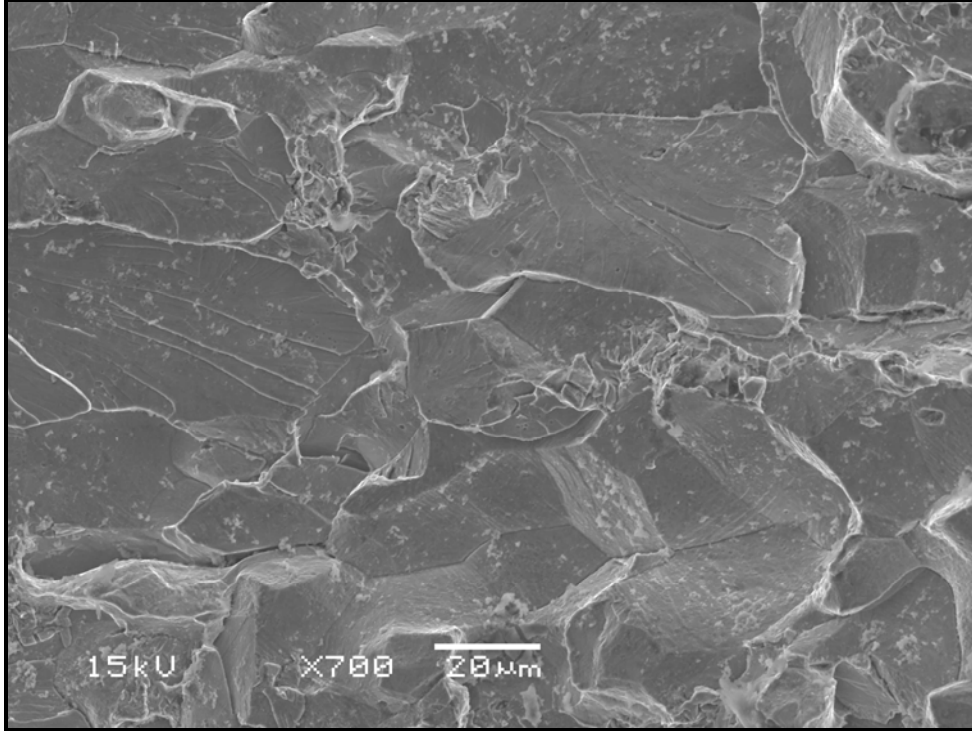
**Figure 17: SEM image of the fracture surface at the origin at higher magnification. Both transgranular cleavage and intergranular fracture are evident in the figure.**

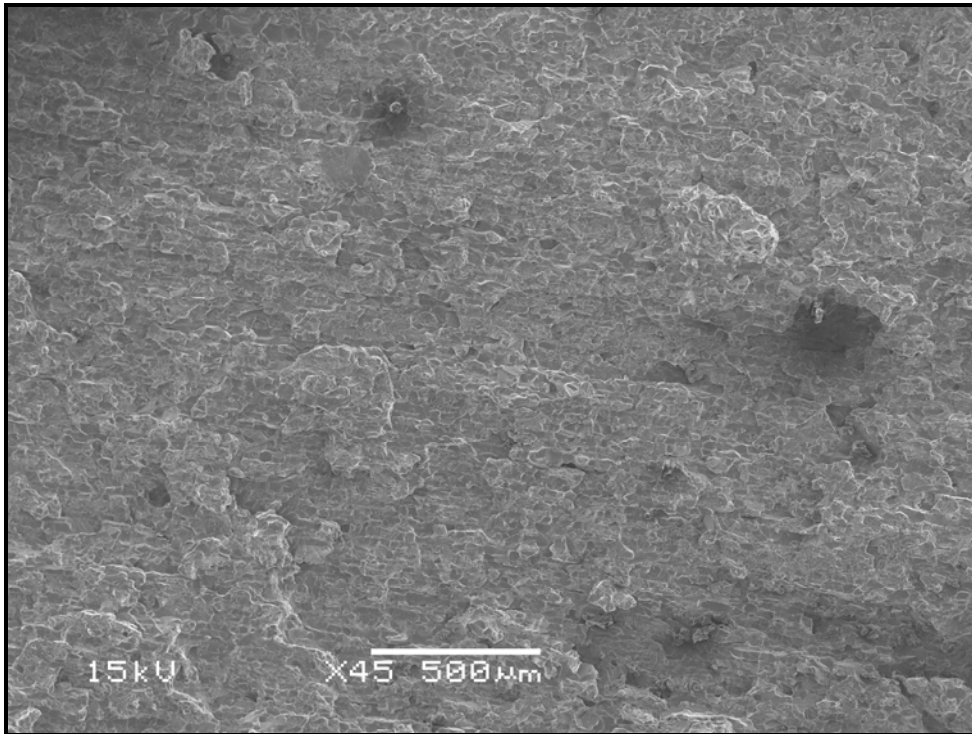
**Figure 18: SEM image of the fracture surface away from the origin.**

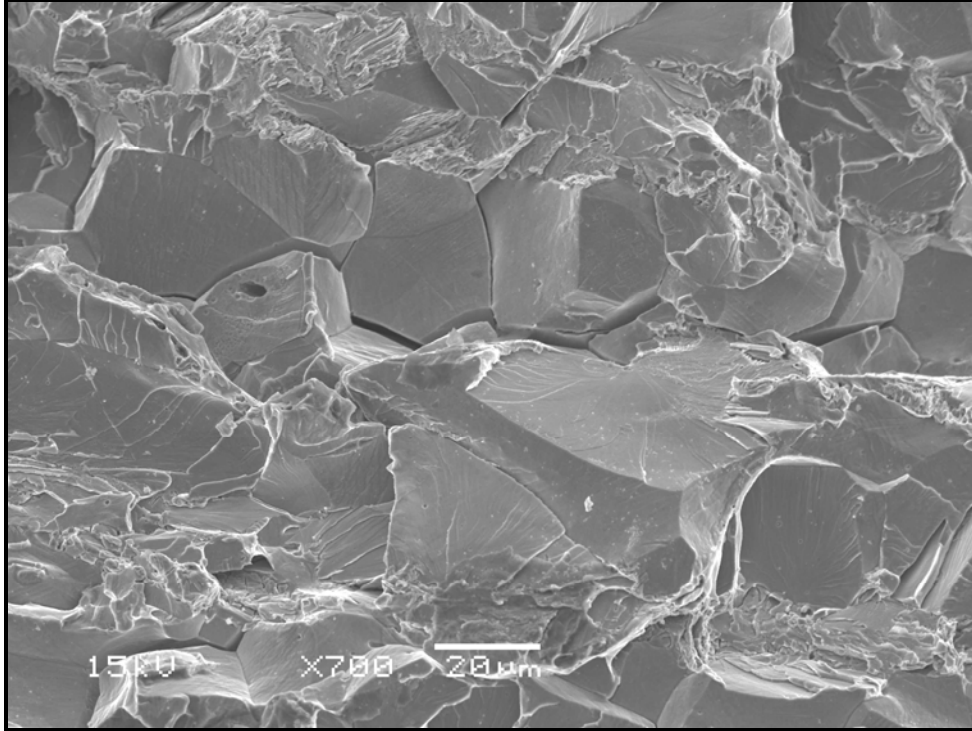
**Figure 19: SEM image of the fracture surface away from the origin at higher magnification. Both transgranular cleavage and intergranular fracture are evident in the figure.**

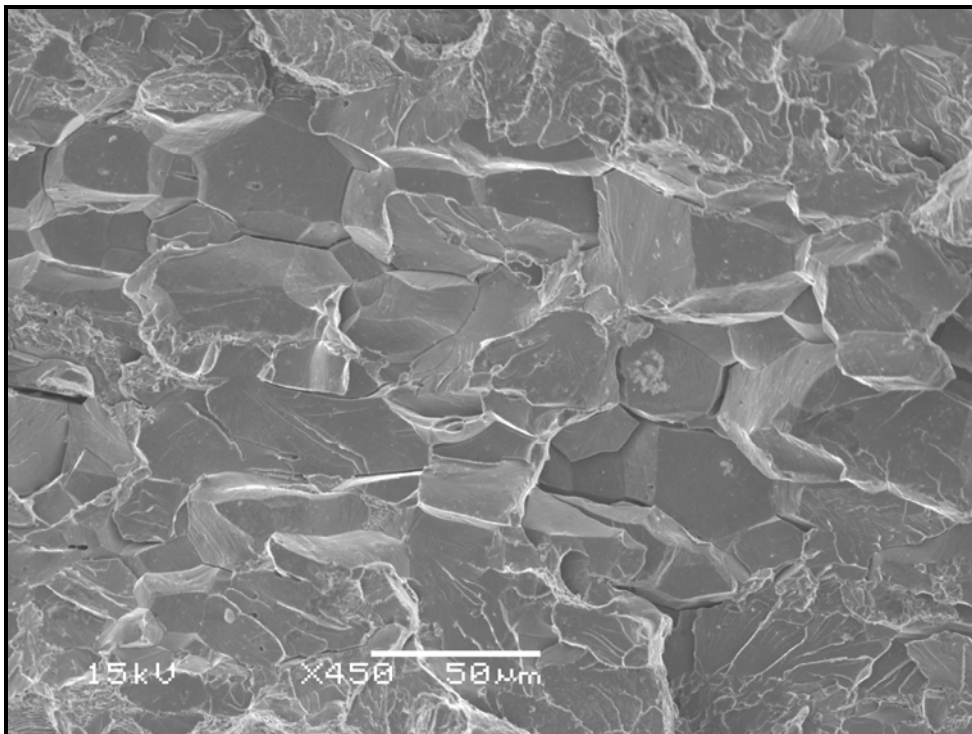
**Figure 20: SEM image of the fracture surface away from the fracture origin. Both transgranular cleavage and intergranular fracture are evident in the figure.**

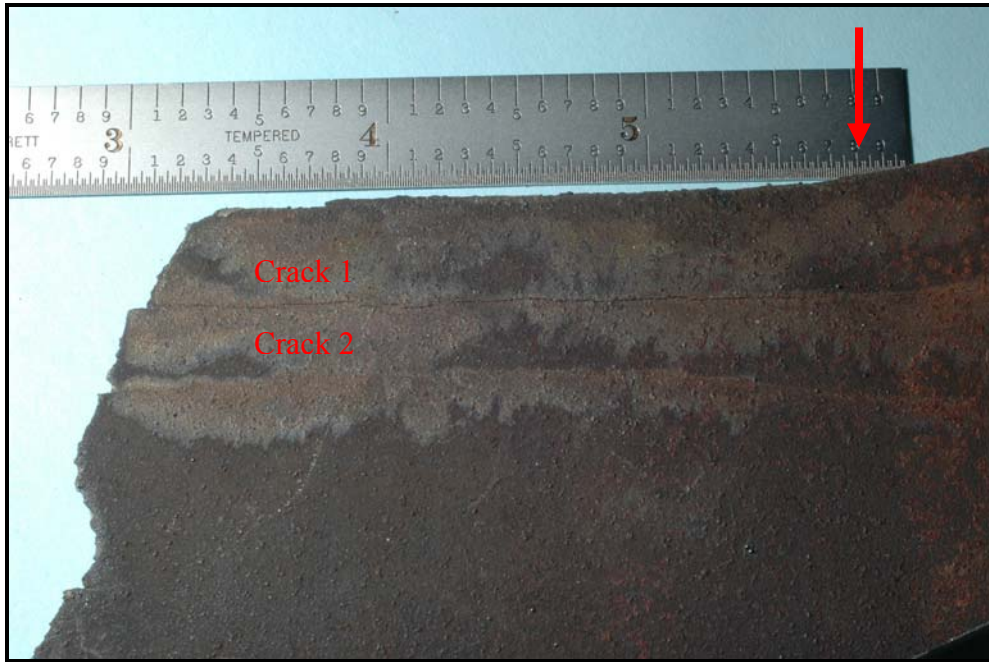
**Figure 21: Shows the two cracks found on the inside surface of the tank head. Notice how the cracks run parallel to the fracture. Red arrow points to the approximate fracture origin.**

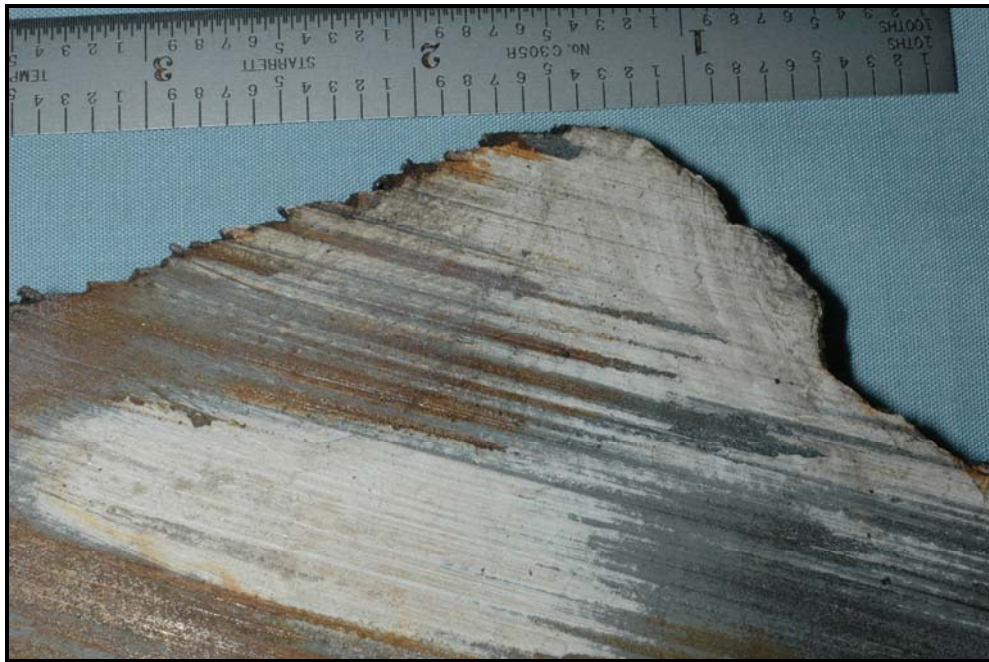
**Figure 22: Shows that the cracks on the inside surface have not extended to the outside surface of the tank head.**

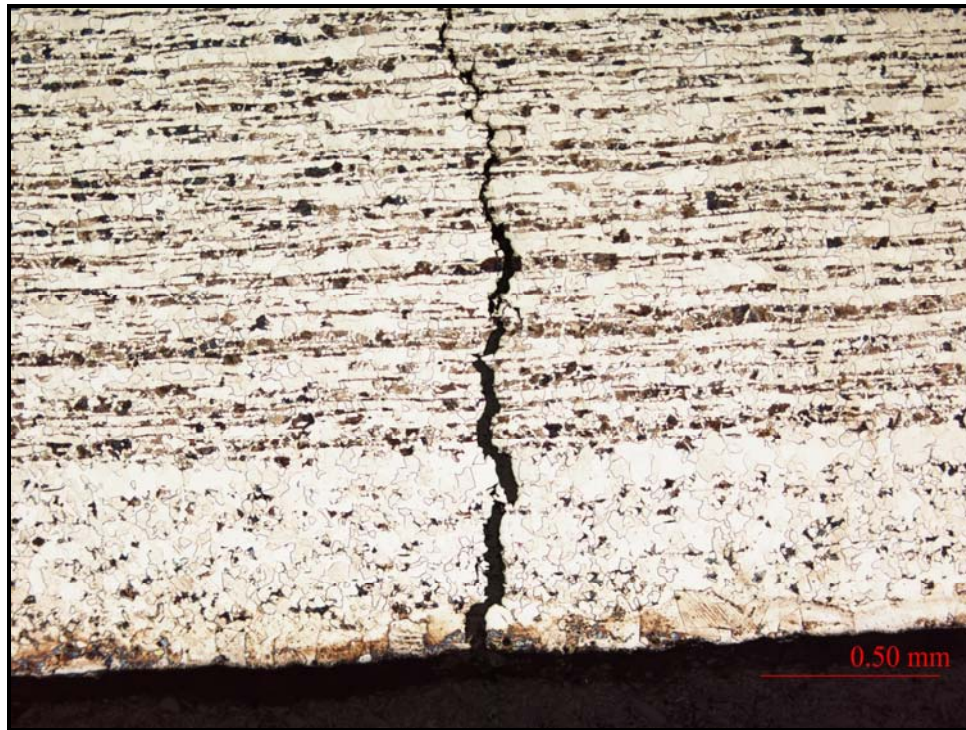
**Figure 23: Metallograph image showing the ferrite/pearlite microstructure and the profile of Crack 1 at the ID of the tank. The steel is decarburized at the ID surface. Magnification: 50 X. Etchant: 2% Nital**

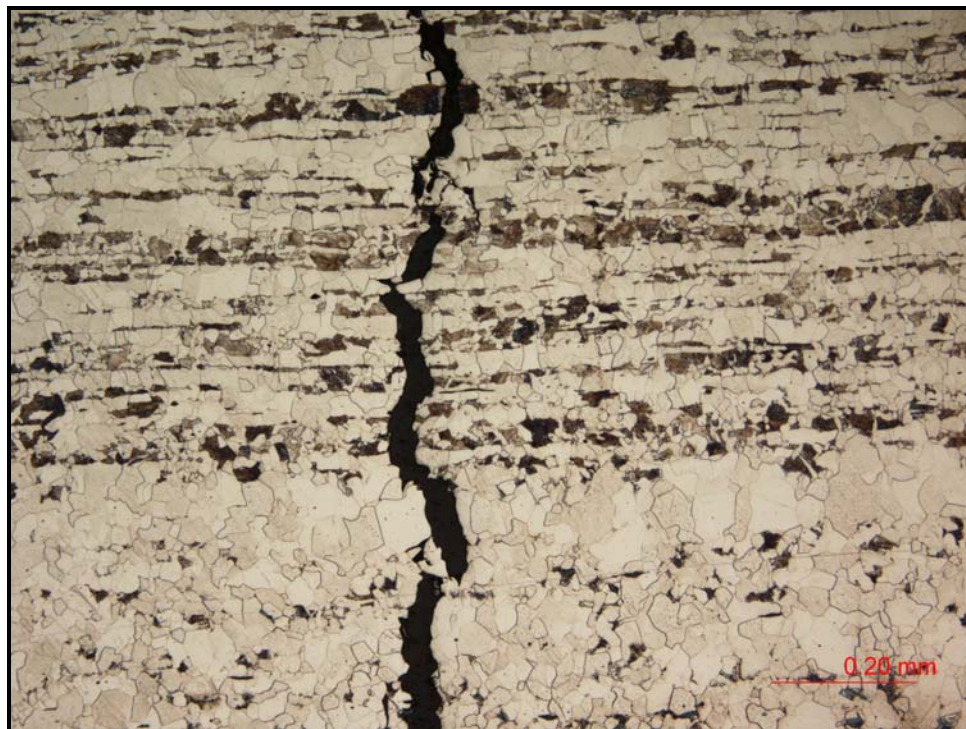
**Figure 24: Same area as Figure 23 at higher magnification. Magnification: 100 X. Etchant: 2% Nital**

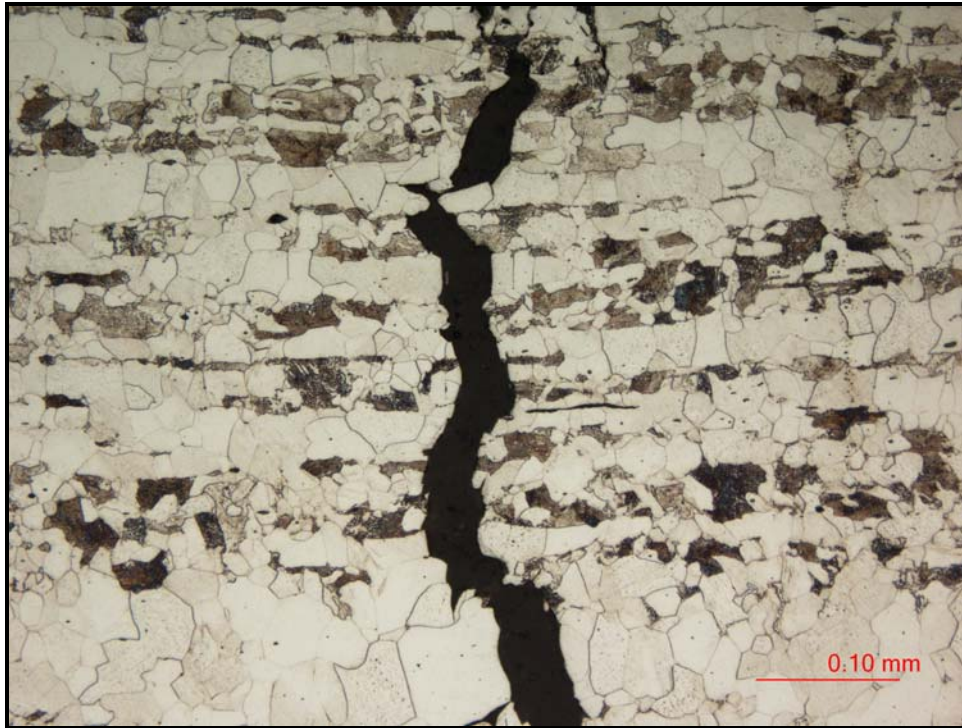
**Figure 25: Same area as Figure 23 showing the trangranular and intergranular nature of the crack. Magnification: 200 X. Etchant: 2% Nital**

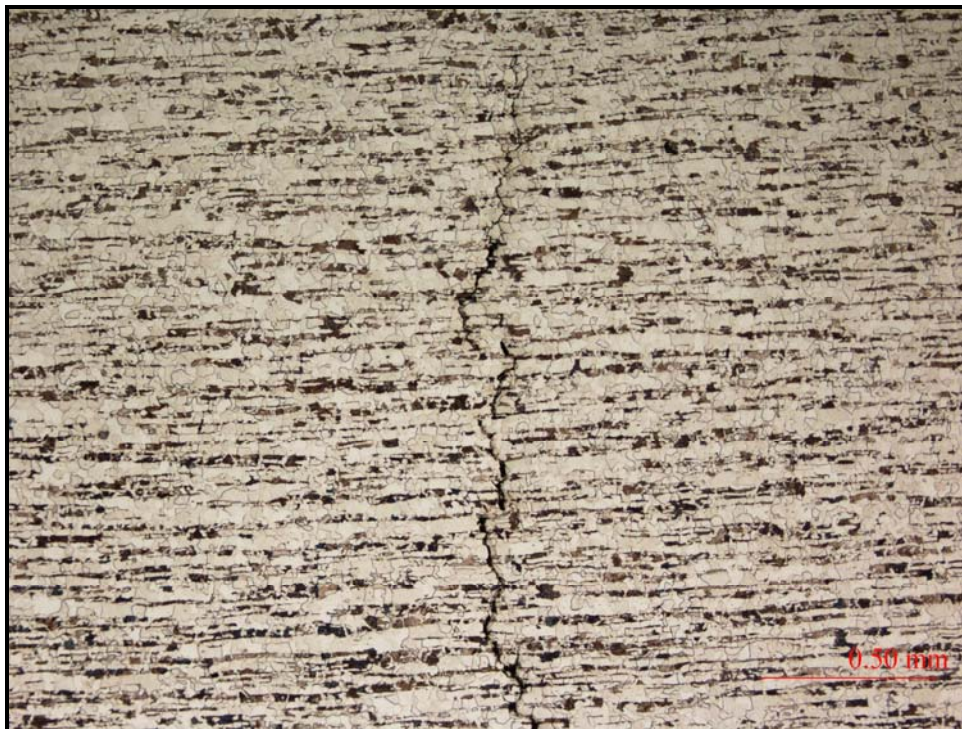
**Figure 26: Metallograph image showing the ferrite/pearlite microstructure at tip of Crack 1. Image also shows the general profile of Crack 1 at the crack tip. Magnification: 50 X. Etchant: 2% Nital**

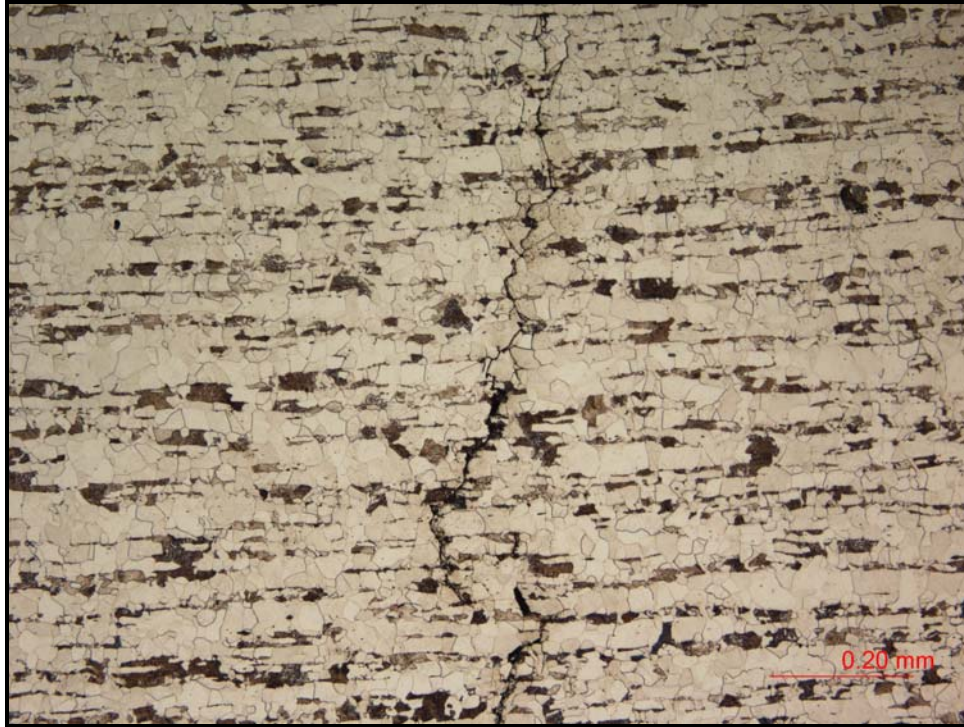
**Figure 27: Same area as Figure 26 at higher magnification. Notice the crack branching at the crack tip. Magnification: 100 X. Etchant: 2% Nital**

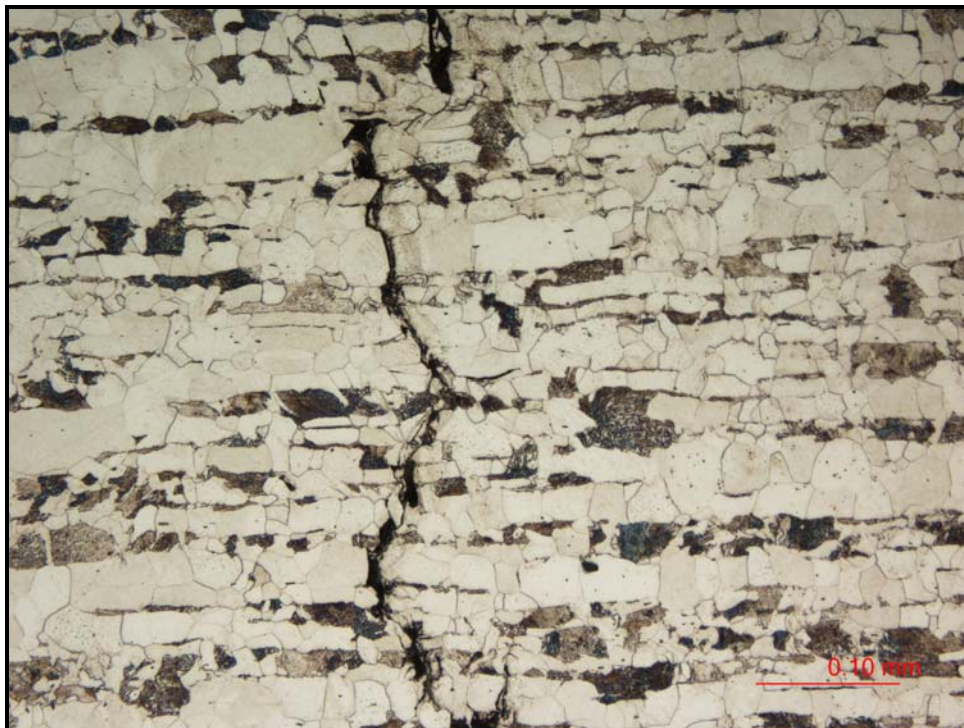
**Figure 28: Same area as Figure 26 at higher magnification. Notice the crack branching at the crack tip. Both intergranular and transgranular crack propagation are evident in the figure. Magnification: 200 X. Etchant: 2% Nital.**

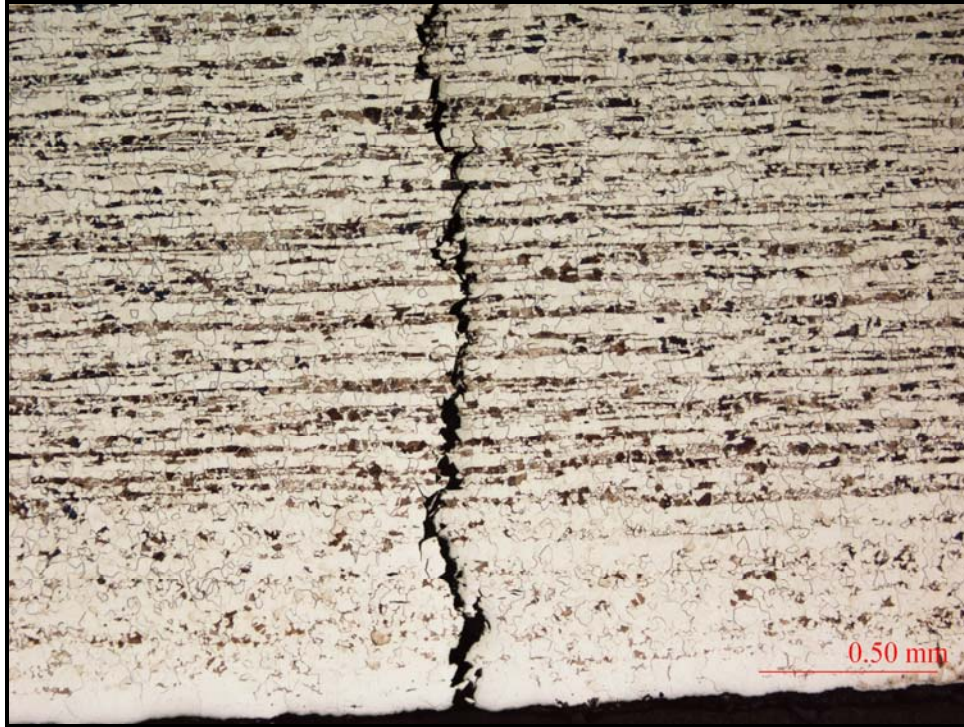
**Figure 29: Shows the ferrite/pearlite microstructure and Crack 2 profile at the beginning of the cut section. Magnification: 50 X. Etchant: 2% Nital**

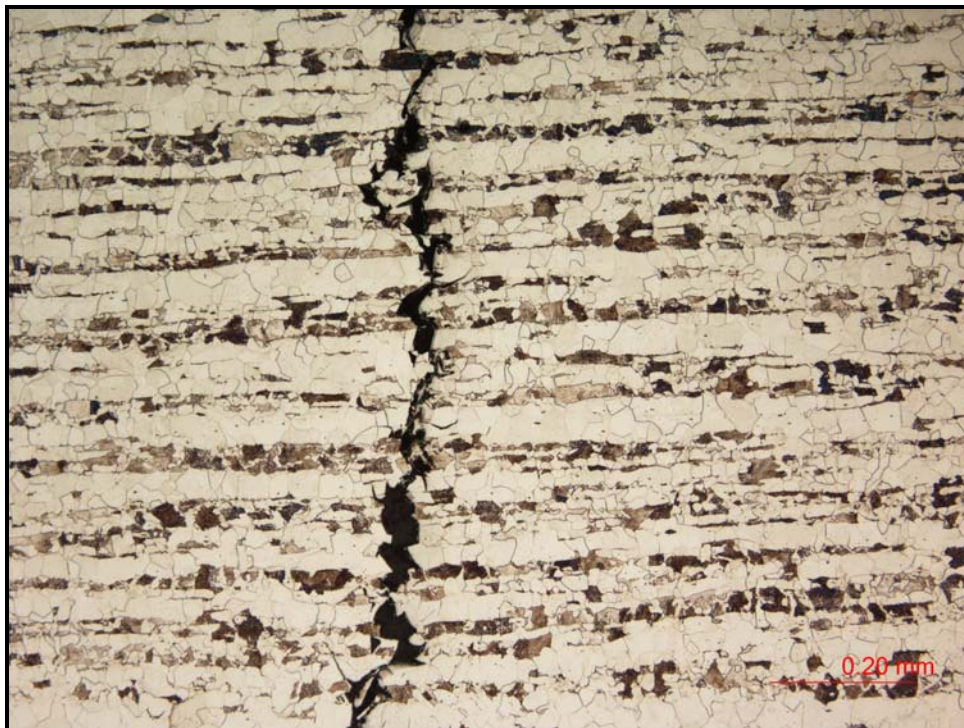
**Figure 30: Same area as Figure 29 at higher magnification. Magnification: 100 X. Etchant: 2% Nital**

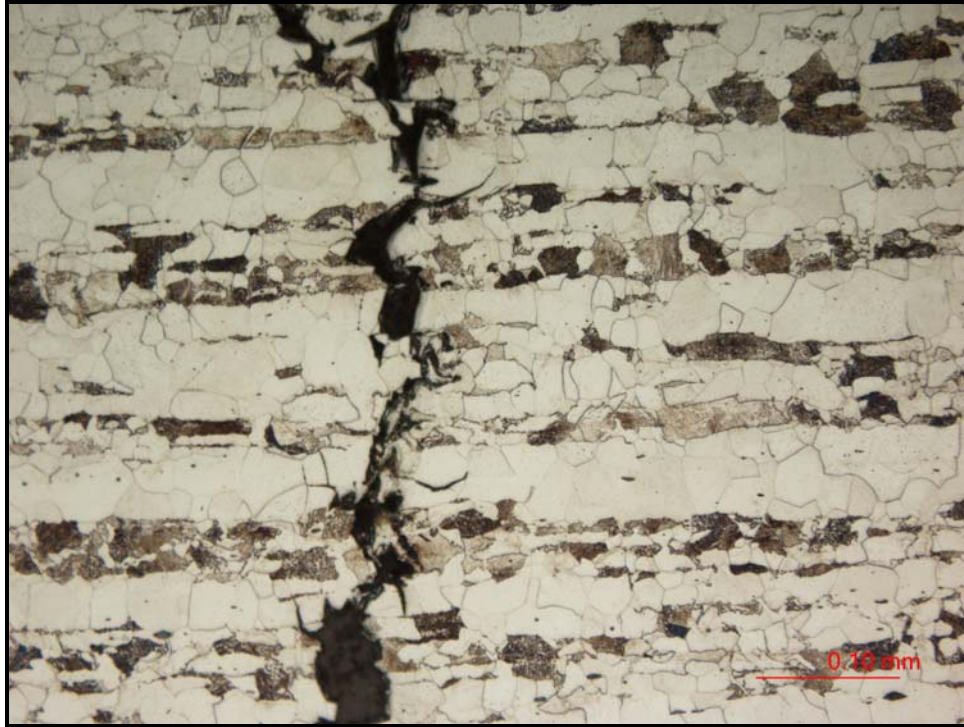
**Figure 31: Same area as Figure 29 at higher magnification. The crack is trangranular and intergranular. Magnification: 200 X. Etchant: 2% Nital**

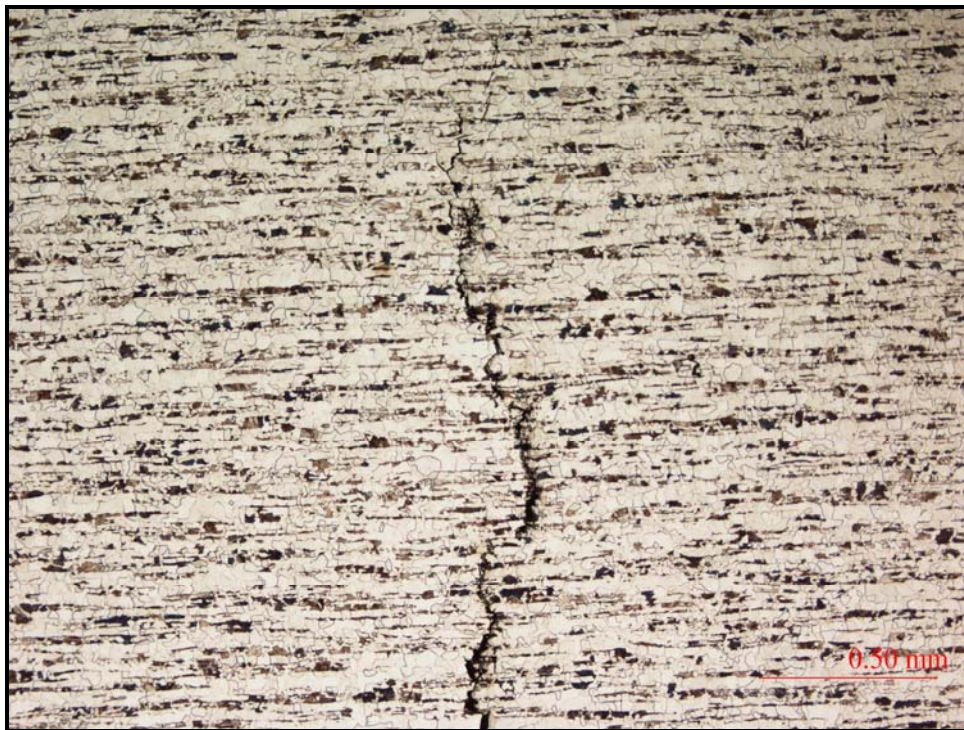
**Figure 32: Shows the ferrite/pearlite microstructure and Crack 2 profile at the end of the crack. Magnification: 50 X. Etchant: 2% Nital**

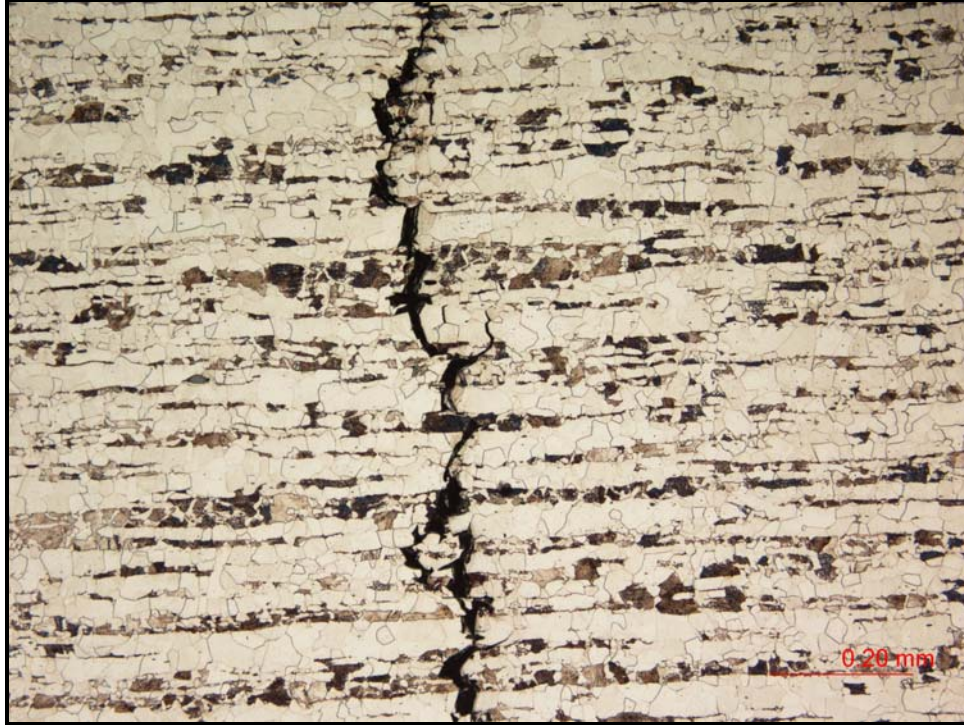
**Figure 33: Same area as Figure 32 at higher magnification.  
Magnification: 100 X. Etchant: 2% Nital**

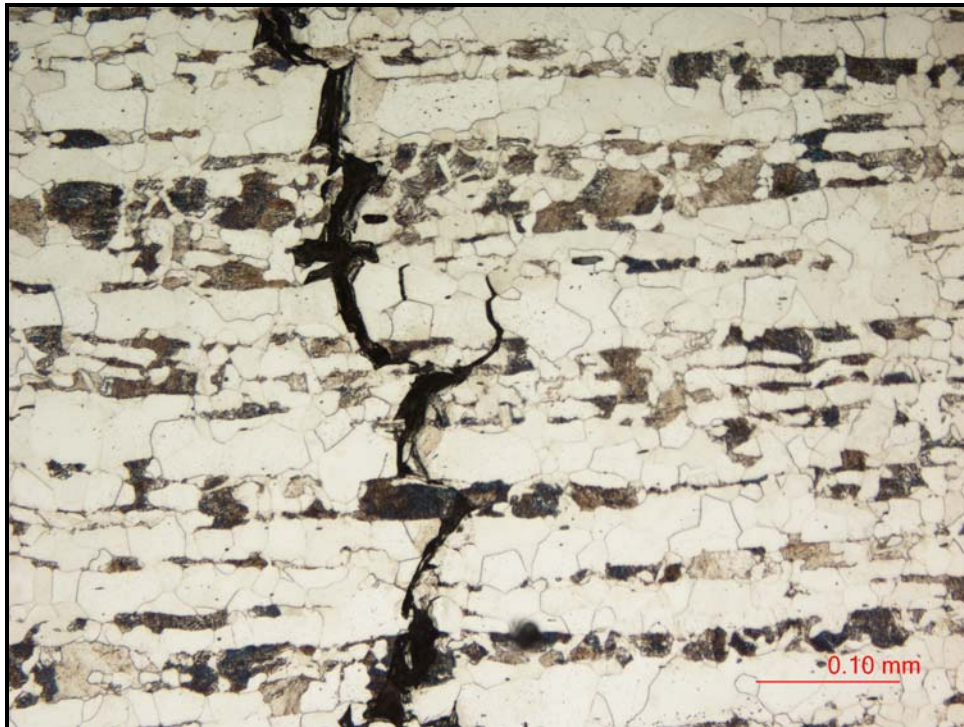
**Figure 34: Same area as Figure 32 at higher magnification. The crack is trangranular and intergranular. Magnification: 200 X. Etchant: 2% Nital**
