**PACKER ENGINEERING INC,**  
1950 North Washington Street,  
Naperville, IL 60566

**Metallurgical Evaluation of a Nurse Tank Cracked Head**

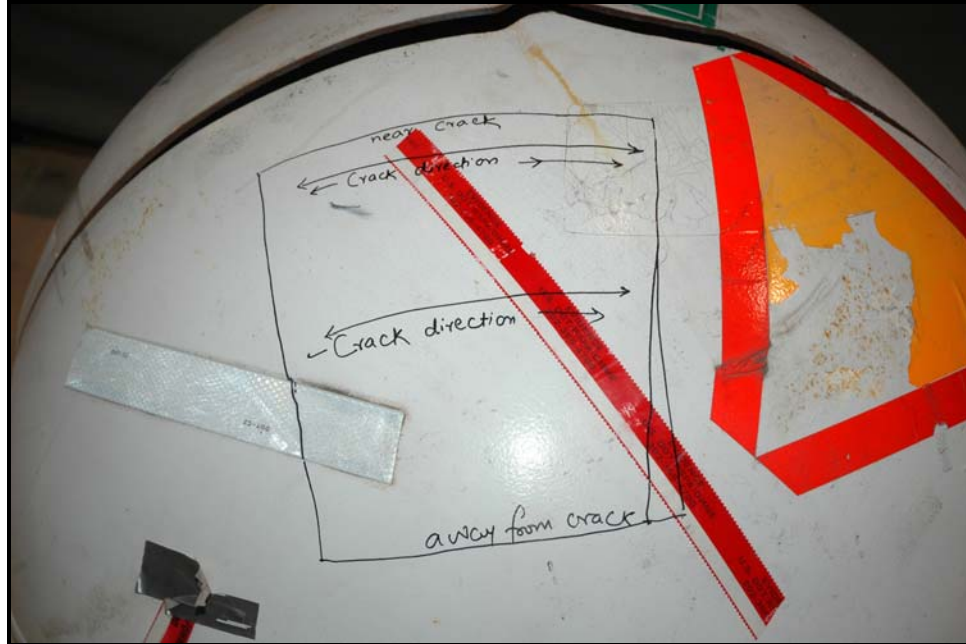
**Figure 35: Shows the location on the tank head from where the samples were prepared for chemistry, hardness, tensile, impact and fracture toughness testing.**
