Department of Toxic Substances Control Site Visit Report			
To:	Folashade Simpson	Date(s) of Visit:	12/05/14
From:	Christine Bucklin	Weather:	Sunny/mild
Site/Project Name:	Pasadena Firing Range		
PCA/SiteCode/WR#:	301637		
Purpose of Visit:	Observe site conditions		
Summary of Activities:			
<ul style="list-style-type: none"> Field recon of project area 			
Personnel Onsite		Title

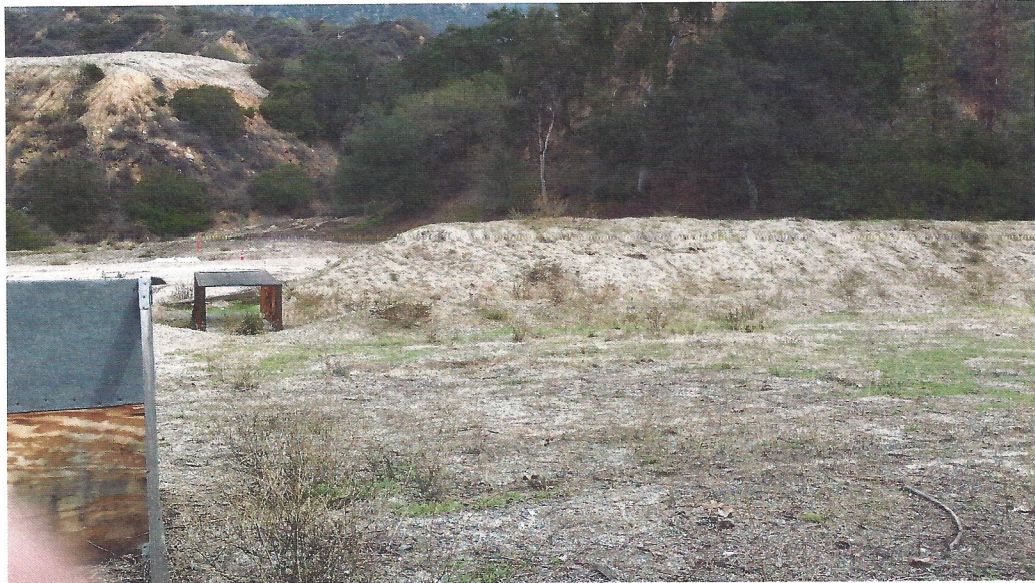
1

General site conditions looking north

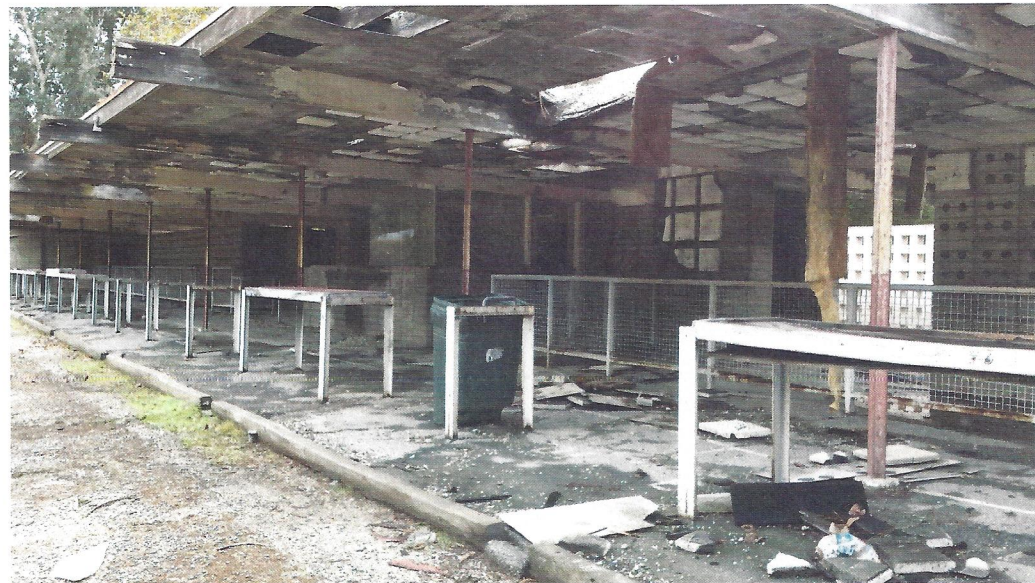
2

General condition of onsite building, looking southeast

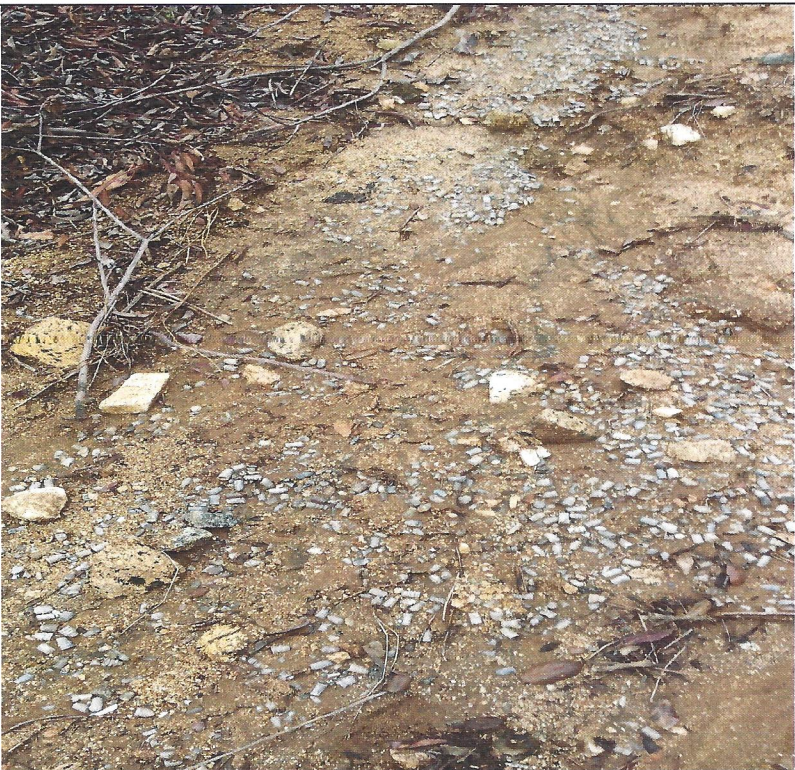
3	Photo of bullet casings and fragments across various areas of the site

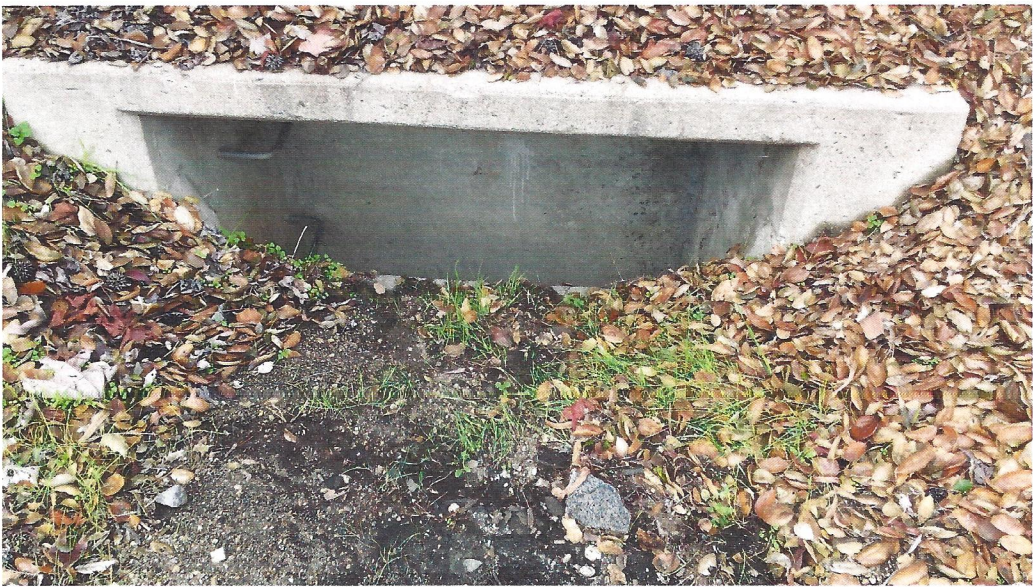
4	Stormwater drain, directly adjacent to the main building – no screen or barrier Drains directly to Eaton Canyon Wash

Comments:			
<ul style="list-style-type: none"> DTSC field staff recommend further investigation of storm drain elements, end discharge pipe along eaton canyon wash and west side berms behind new indoor shooting range Dtsc needs to further examine ceqa needs for this site and extended areas of clean up 			
Attachment(s):			
<ul style="list-style-type: none"> Photo log

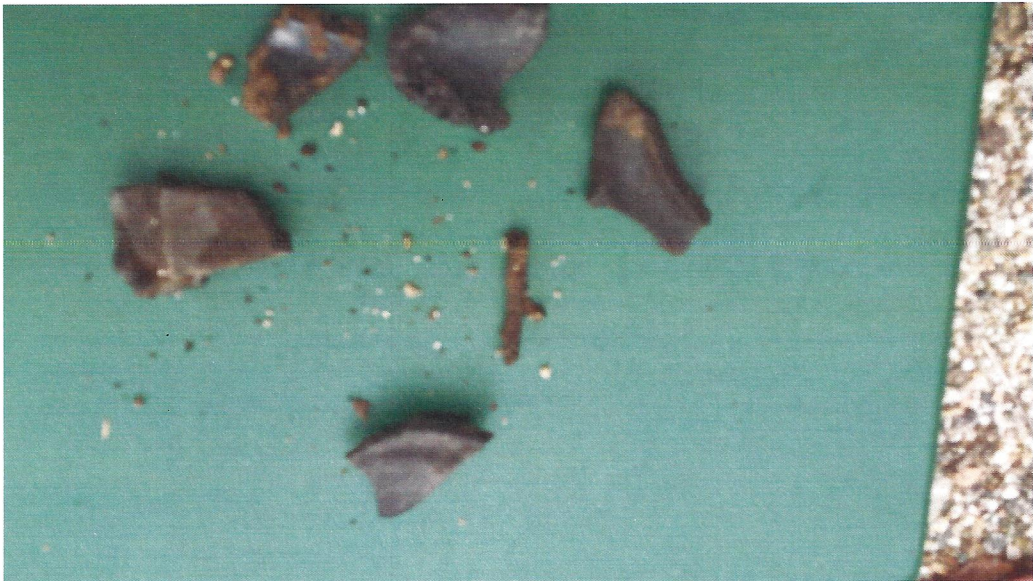
5	Clay pigeon fragments observed at base of likely former range on west side of site behind new indoor shooting range

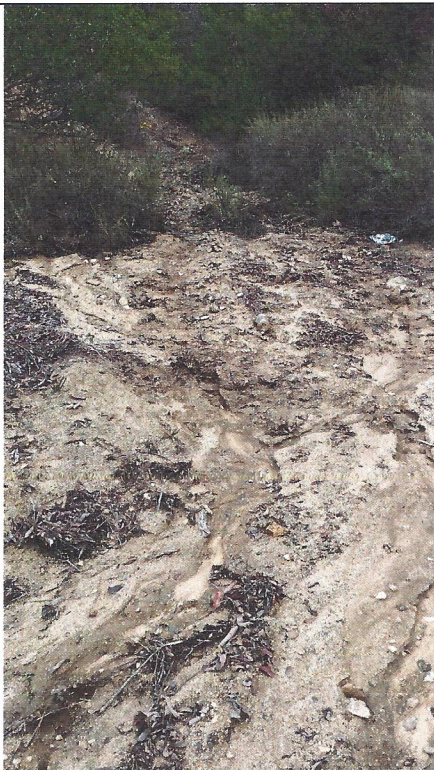
6	Washdown from higher berm and backstop, bullet casings apparent

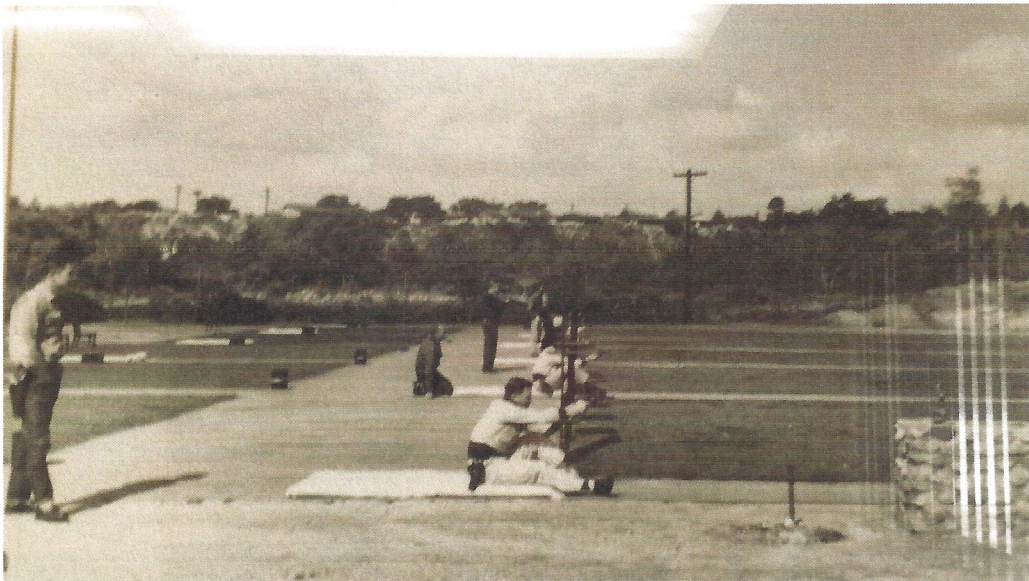
7	Old photos from wall, shows the range was larger in the past.

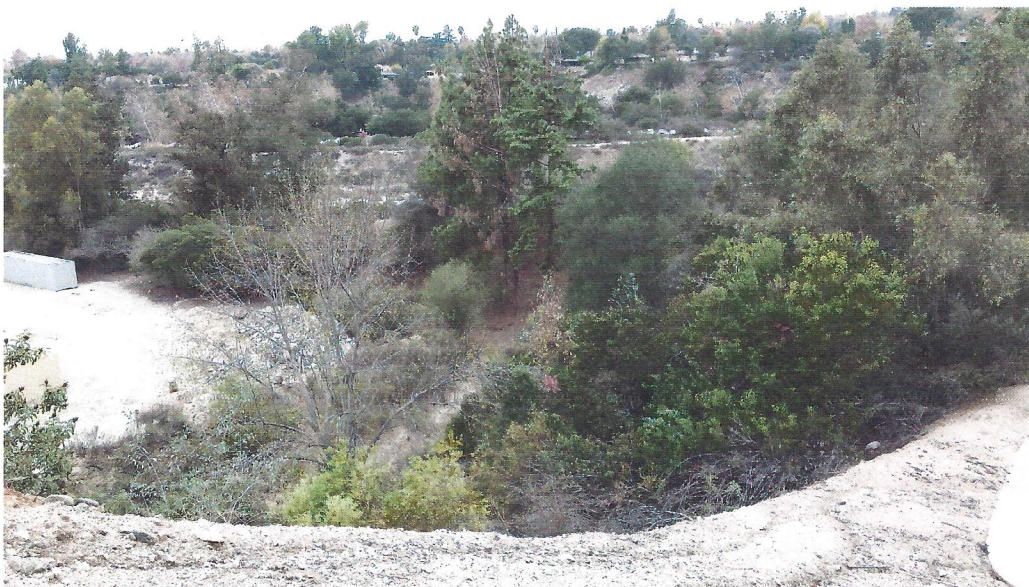
8	Looking down from the top, east (this area is behind the new indoor range) and has not been sampled, but casings and clay pigeon debris are present

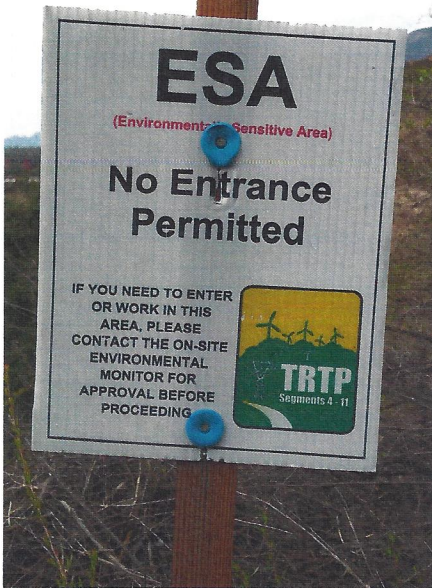
9	ESA post – unclear who posted this and what it may refer to; possibly Tehachapi Renewable Transmission Project
10
