Legal Aid Foundation of Los Angeles

Re: Violations of Required Conditions of HACLA Remediation at 9901 Alameda Street, Los Angeles, CA, 90002

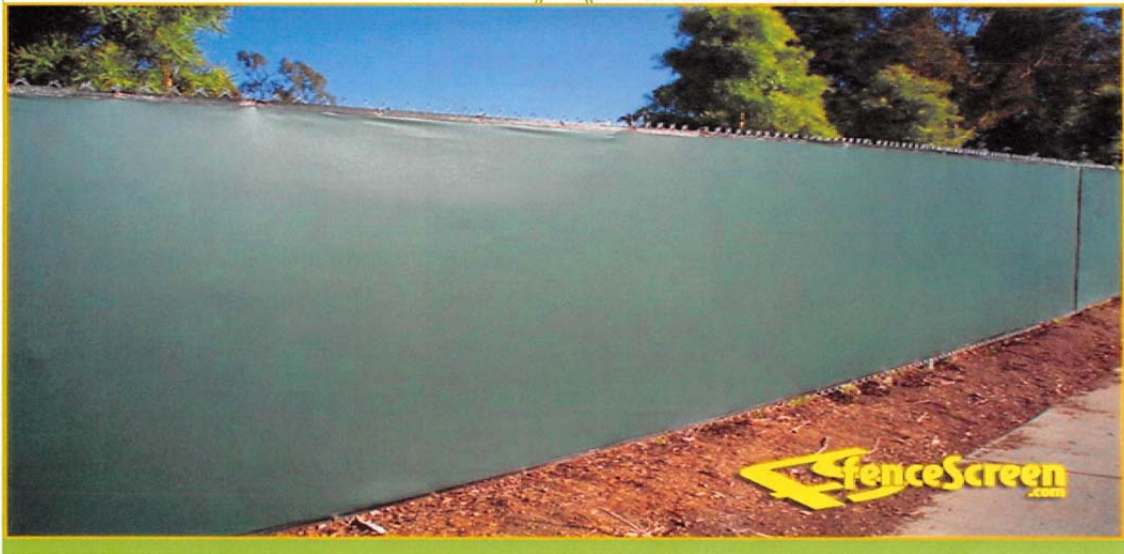
EXHIBIT 1

In our comments to the IRAP, we also identified the need for open and honest communication with residents and the community, in order to inform them of potential risks and the steps to take should potentially harmful exposures occur. For the most part, our suggestions were not incorporated into the final IRAP. Moreover, what communications have been made to residents have been sparse and misleading at best. During a presentation to residents regarding the upcoming remediation, residents were assured that their health would be protected and there was no need for concern. As an example of the protective measures that were promised but never delivered, residents were shown photos of fences tightly covered from top to bottom with windscreens, and of large mounds of soil completely wrapped in plastic sheeting to prevent disturbance. *See Exhibits 1, 2.*

**PHOTO SHOWED DURING PRESENTATION TO RESIDENTS DEPICTING
WINDSCREENS PROMISED ON FENCING**

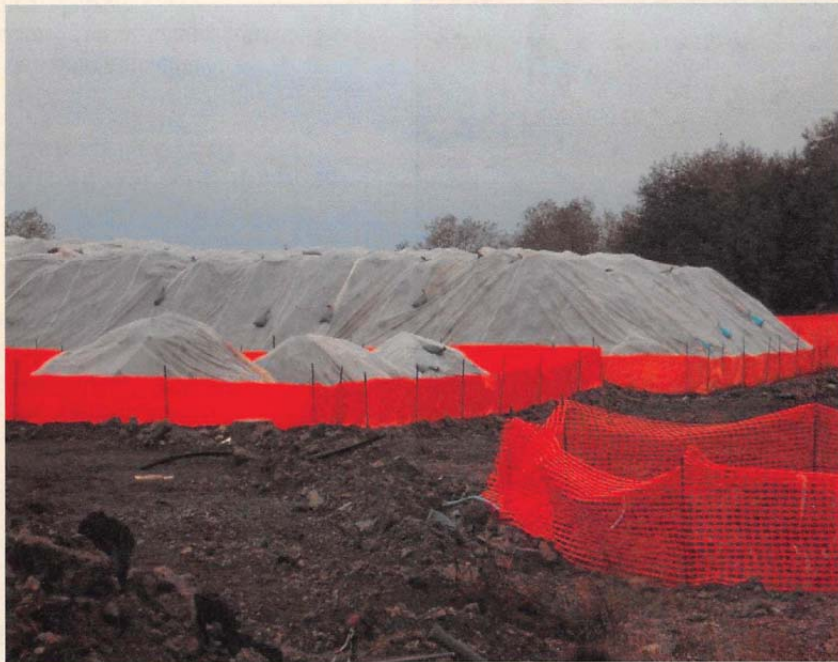
EXHIBIT 2

their potential classification as hazardous waste. *Final IRAP § 7.1.4, at 25; see also Final IRAP § 7.3.2, at 28.* HACLA has represented to residents that stockpiles will be completely covered, and the possibility of dust leaving the Site is minimal. *See Exhibit 2.*

**PHOTO SHOWED DURING PRESENTATION TO RESIDENTS DEPICTING PROMISED
STABILIZATION OF SOIL STORAGE AREAS**

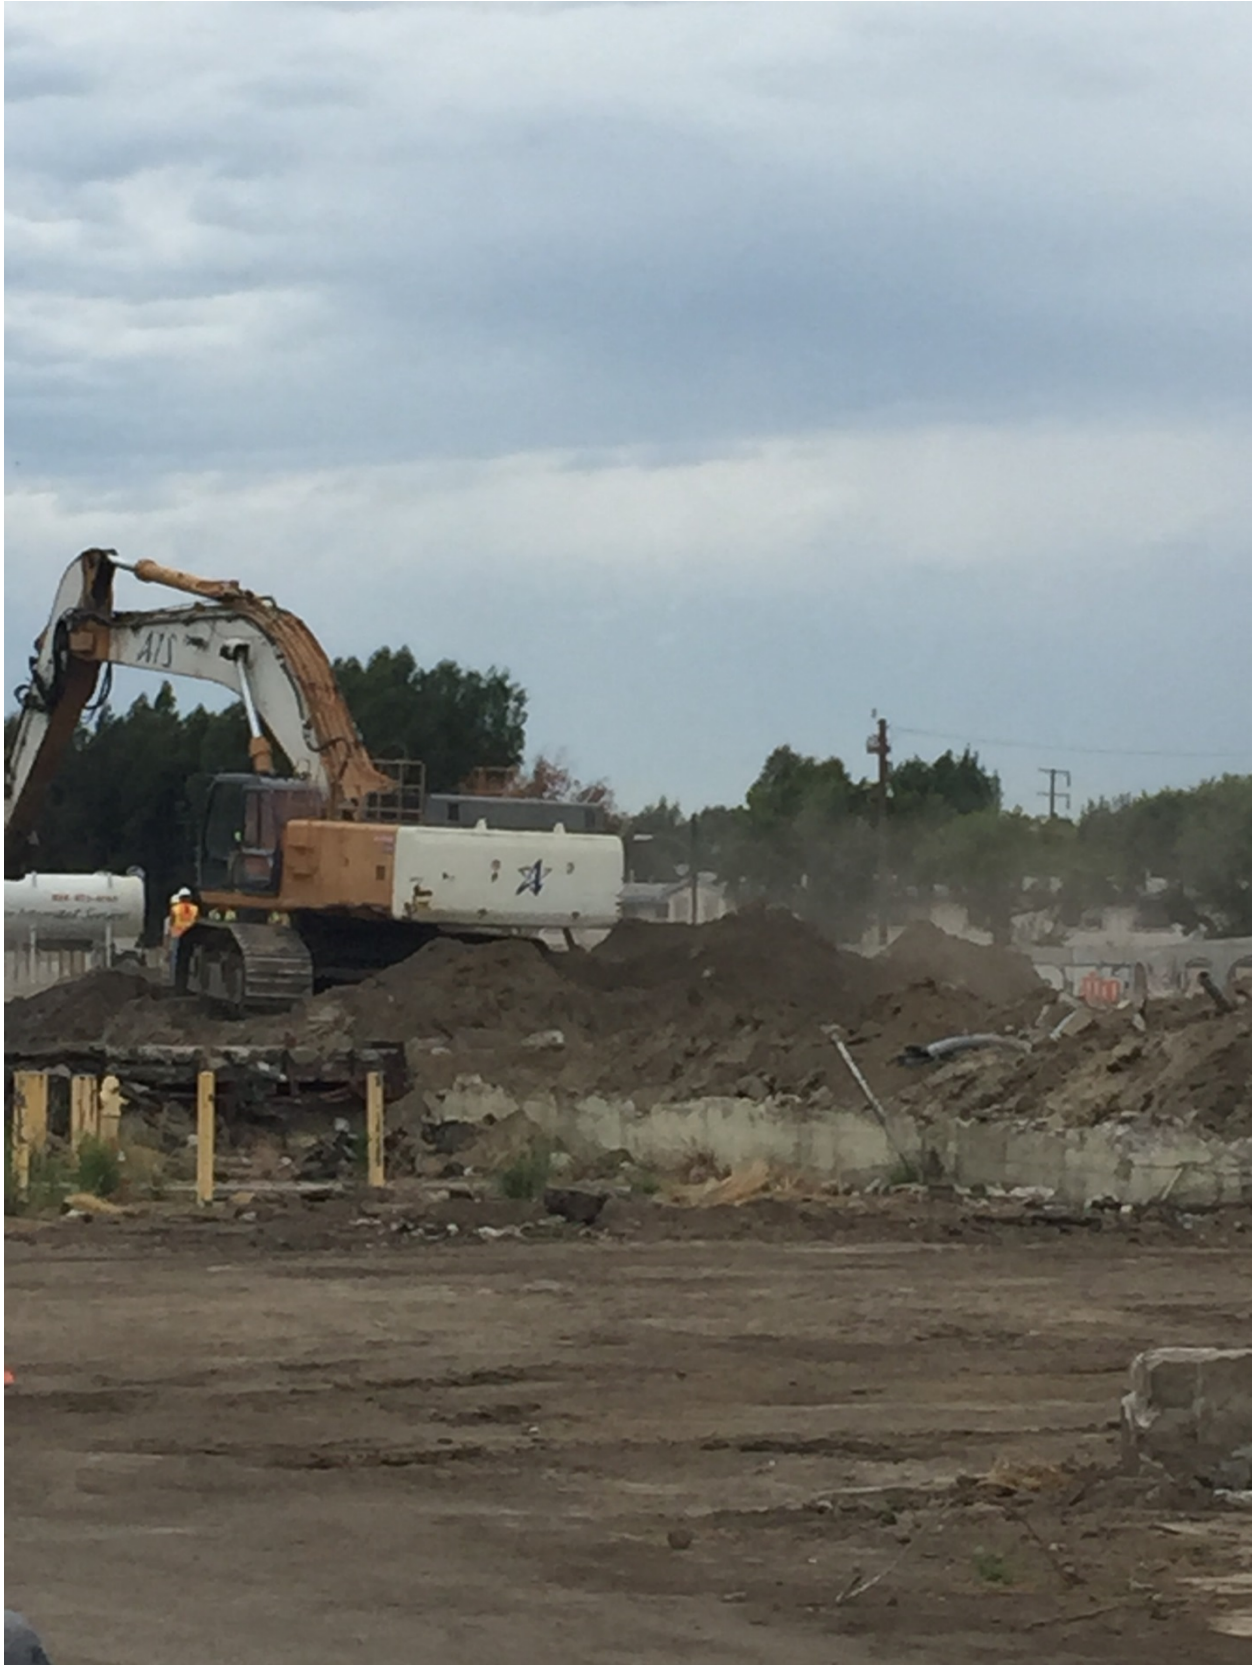
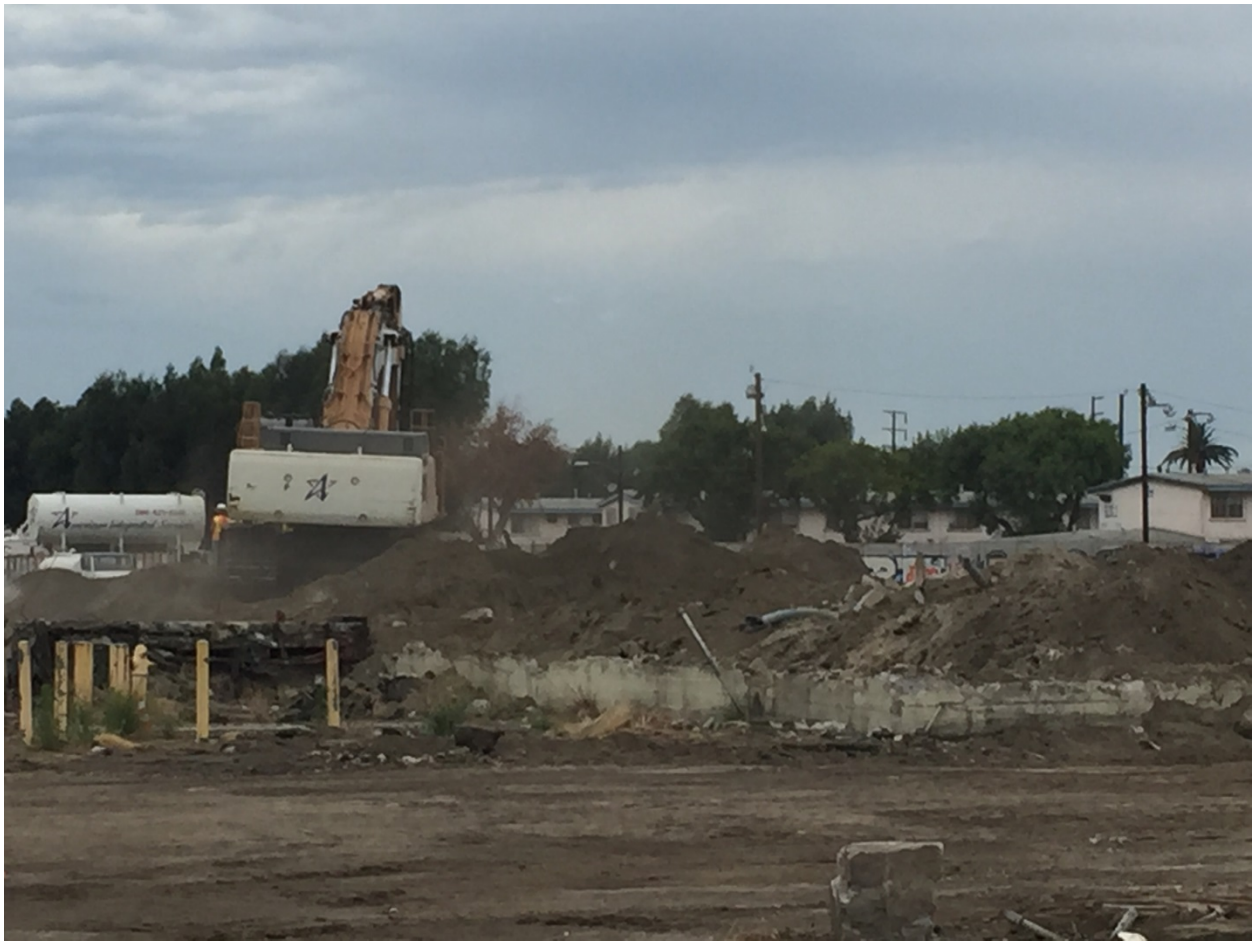
EXHIBIT 3

The IRAP states that "[r]emedial activities will stop if a measured wind velocity exceeds... a sustained speed of 15 mph for more than 15 minutes continuously." *Final IRAP § 7.7.1, at 32*. A review of the weather report for July 1st shows that high winds occurred throughout the afternoon, and wind speeds reached the 15 mph threshold. Further, the IRAP Health and Safety Plan states that "...if visible emissions are suspended and transported beyond the regulated area after dust suppression, work will be suspended." *Final IRAP Health and Safety Plan §8.0, at 15*. When I visited the Site on July 1, visible plumes of dust were being generated by excavation activities, which were being conducted utilizing a large bulldozer-type vehicle. Each time the bulldozer picked up and moved a load of dirt, large clouds of dust were created, which were carried by the wind towards the north side of the site. *See Exhibit 3*. I observed that this work continued during the approximately one and a half hours I spent in the vicinity of the Site, with no evidence of a work stoppage despite the fact that wind speeds may have exceeded the IRAP's threshold and the IRAP clearly requires that work cease when visible emissions of dust are observed migrating off-site *regardless* of wind speed.

EXAMPLES OF VISIBLE DUST EMISSIONS DURING JULY 1ST, 2015 SITE VISIT

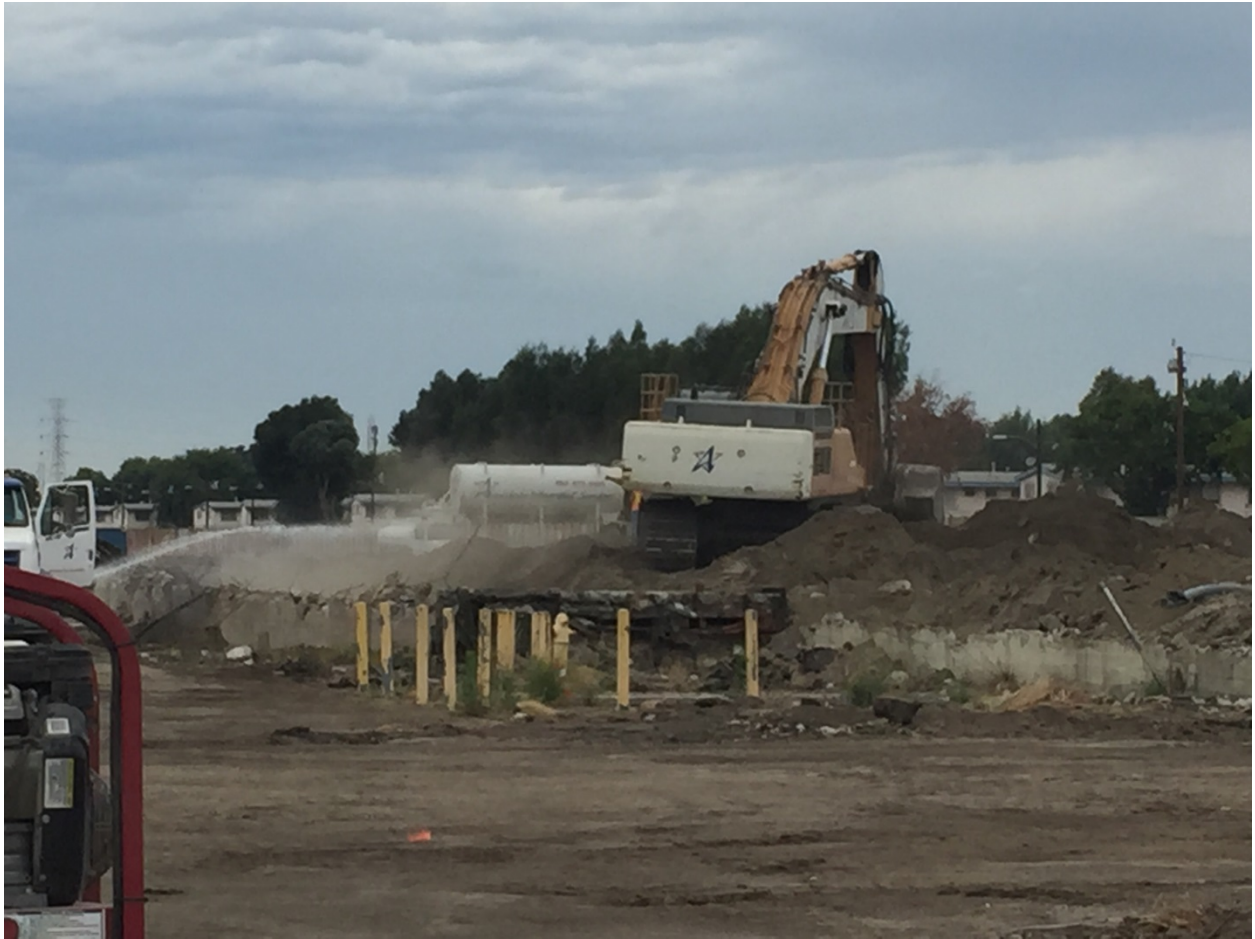
EXHIBIT 4

The IRAP requires active dust suppression activities to take place during the remediation, including the use of water trucks to prevent dust emissions. *Final IRAP § 7.7.1, at 32*. The IRAP states that "[o]ne water truck will be in the excavation area; one water truck will be in the materials segregation area; and two water trucks will be on the transportation route." *Final IRAP Health and Safety Plan §8.0, at 15*. However, I only observed one water truck on-site during my visit, which was not adequately controlling the dust emissions coming from the excavation being performed by the bulldozer-type vehicle. Despite its presence, the use of this single water truck was obviously not effective at controlling the large clouds of dust which were being generated as each load of dirt was dumped onto an adjacent location. *See Exhibit 4*.

INADEQUATE DUST CONTROL

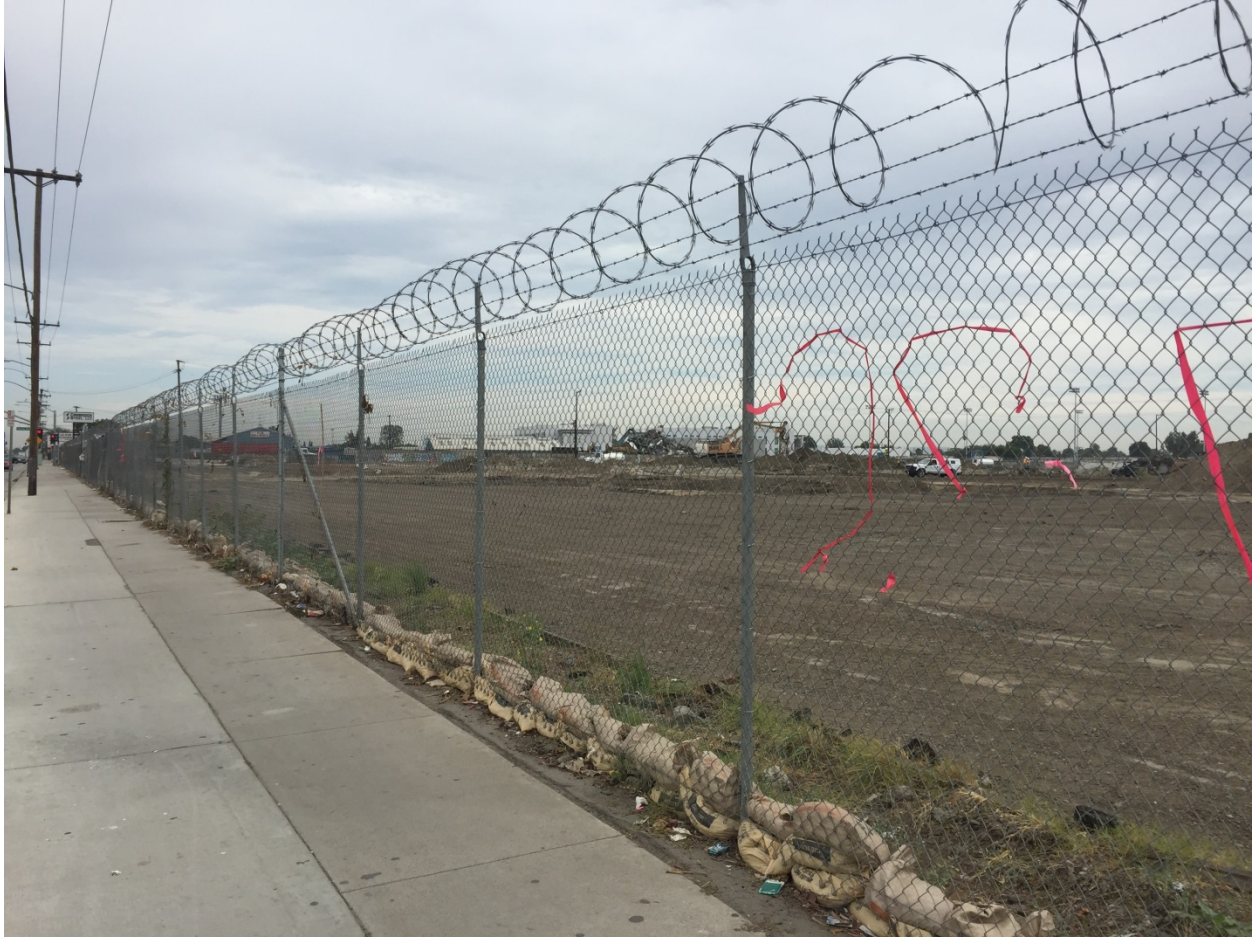
EXHIBIT 5

The IRAP requires that "[p]erimeter fences... be covered with windscreens to assist in controlling dust generated by wind onsite." *Final IRAP § 7.7.1, at 32; see also Final IRAP §§ 7.1.1, 7.1.3, at 25*. Further, HACLA has represented to residents that it will cover all fences with windscreens to protect them from dust. *See Exhibit 1*. However, my visit to the Site and those portions of Jordan Downs surrounding the Site revealed the use of fence screens to be extremely inadequate. The chain-link fence bordering the work site along Alameda Street was open and exposed, with no dust control or other screens covering it. *See Exhibit 5*. Several pedestrians walked or biked by in the short time I was standing on this side of the Site, which is completely unprotected. The only dust screens I observed were surrounding Jordan High School, but these were only a few feet high and some had large gaps.

**UNCOVERED CHAIN-LINK FENCE ON ALAMEDA STREET BORDERING
REMEDICATION SITE**

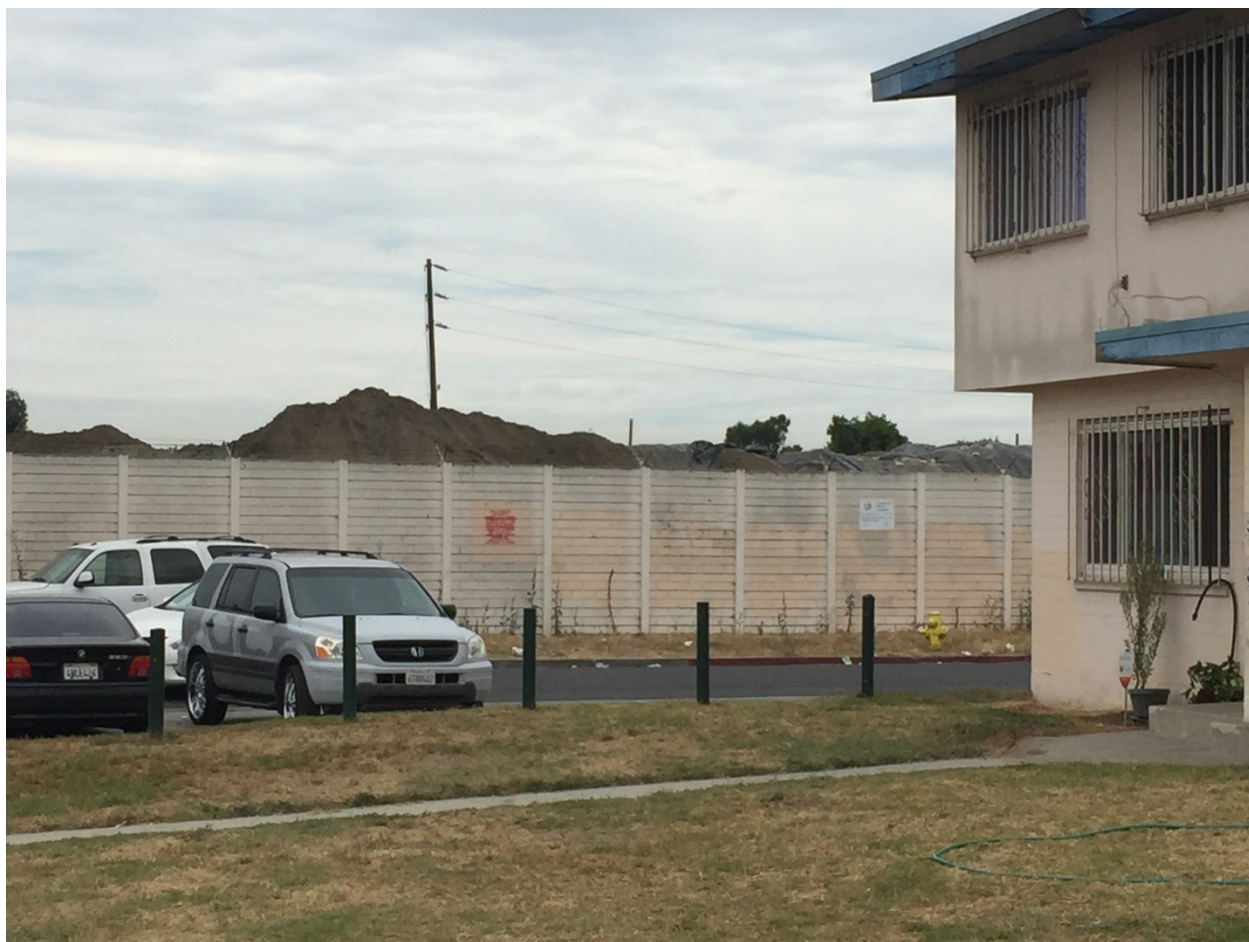
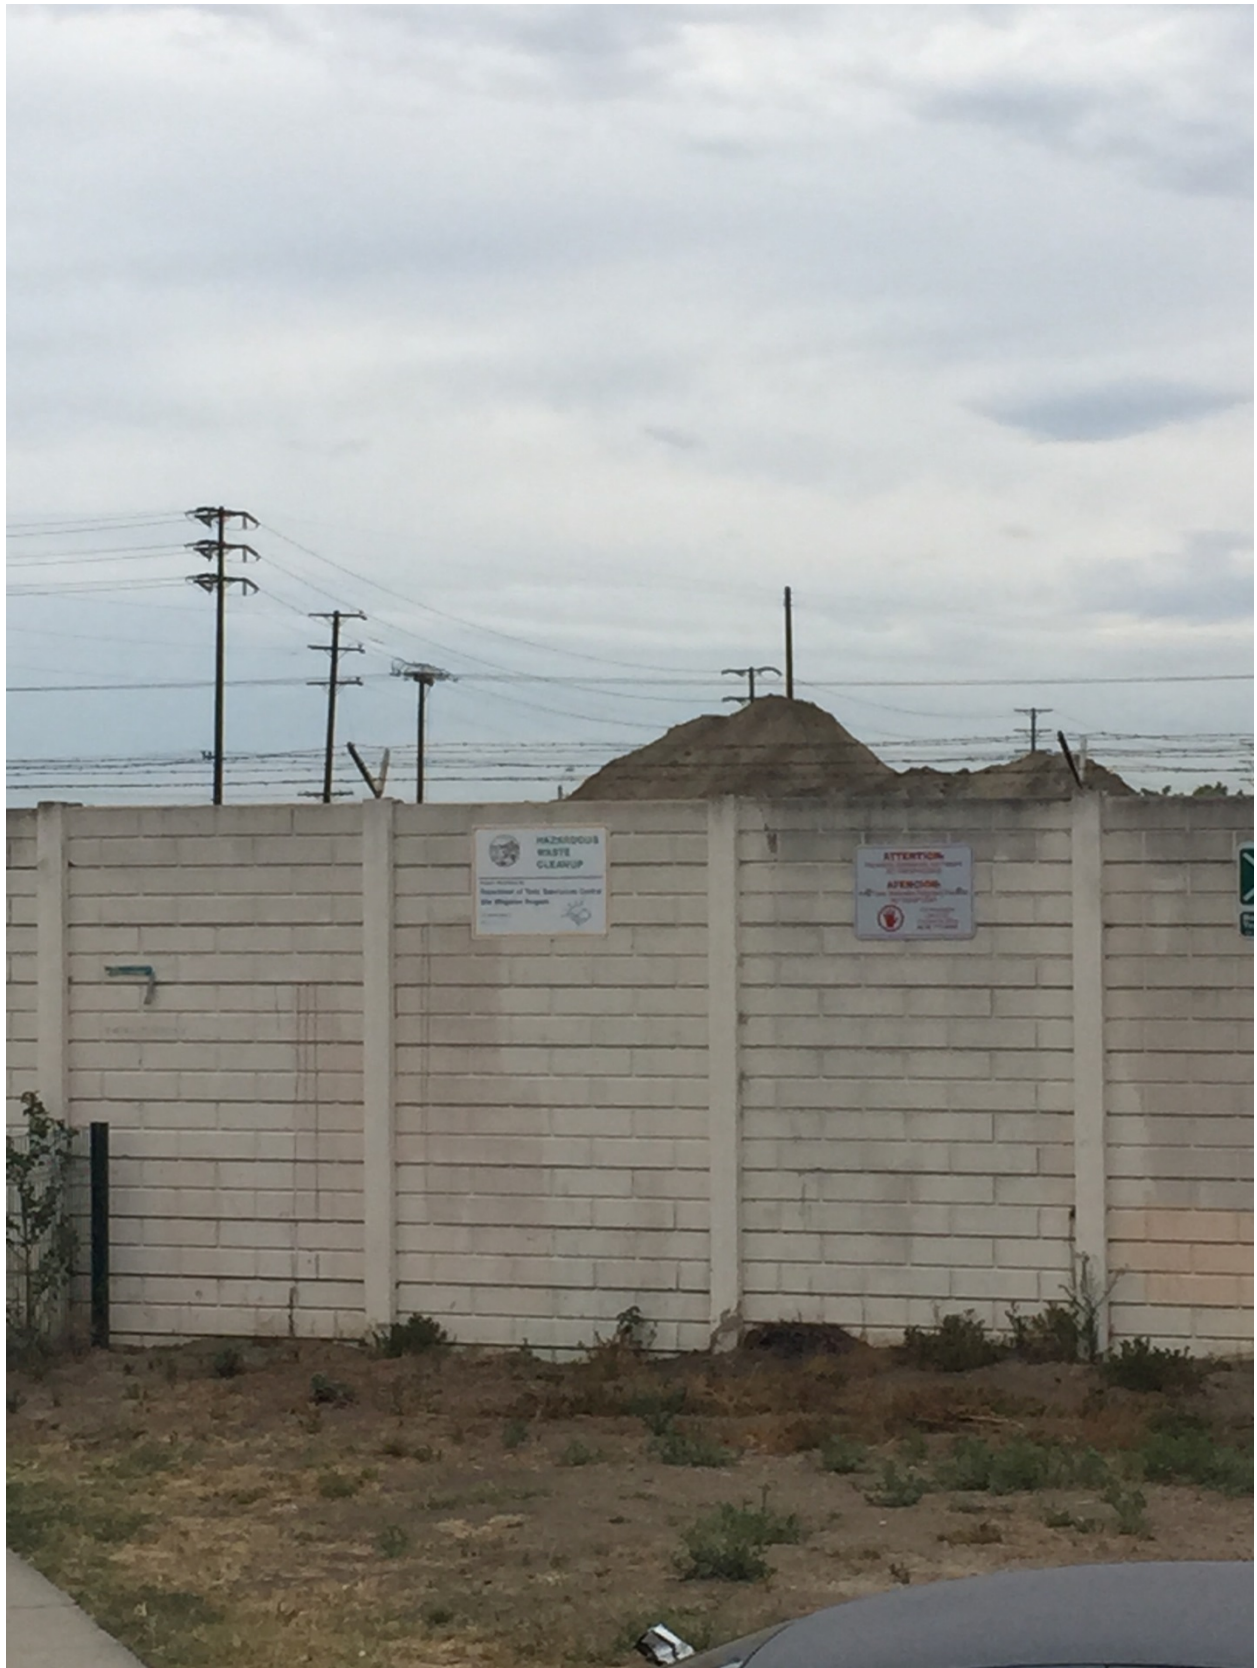
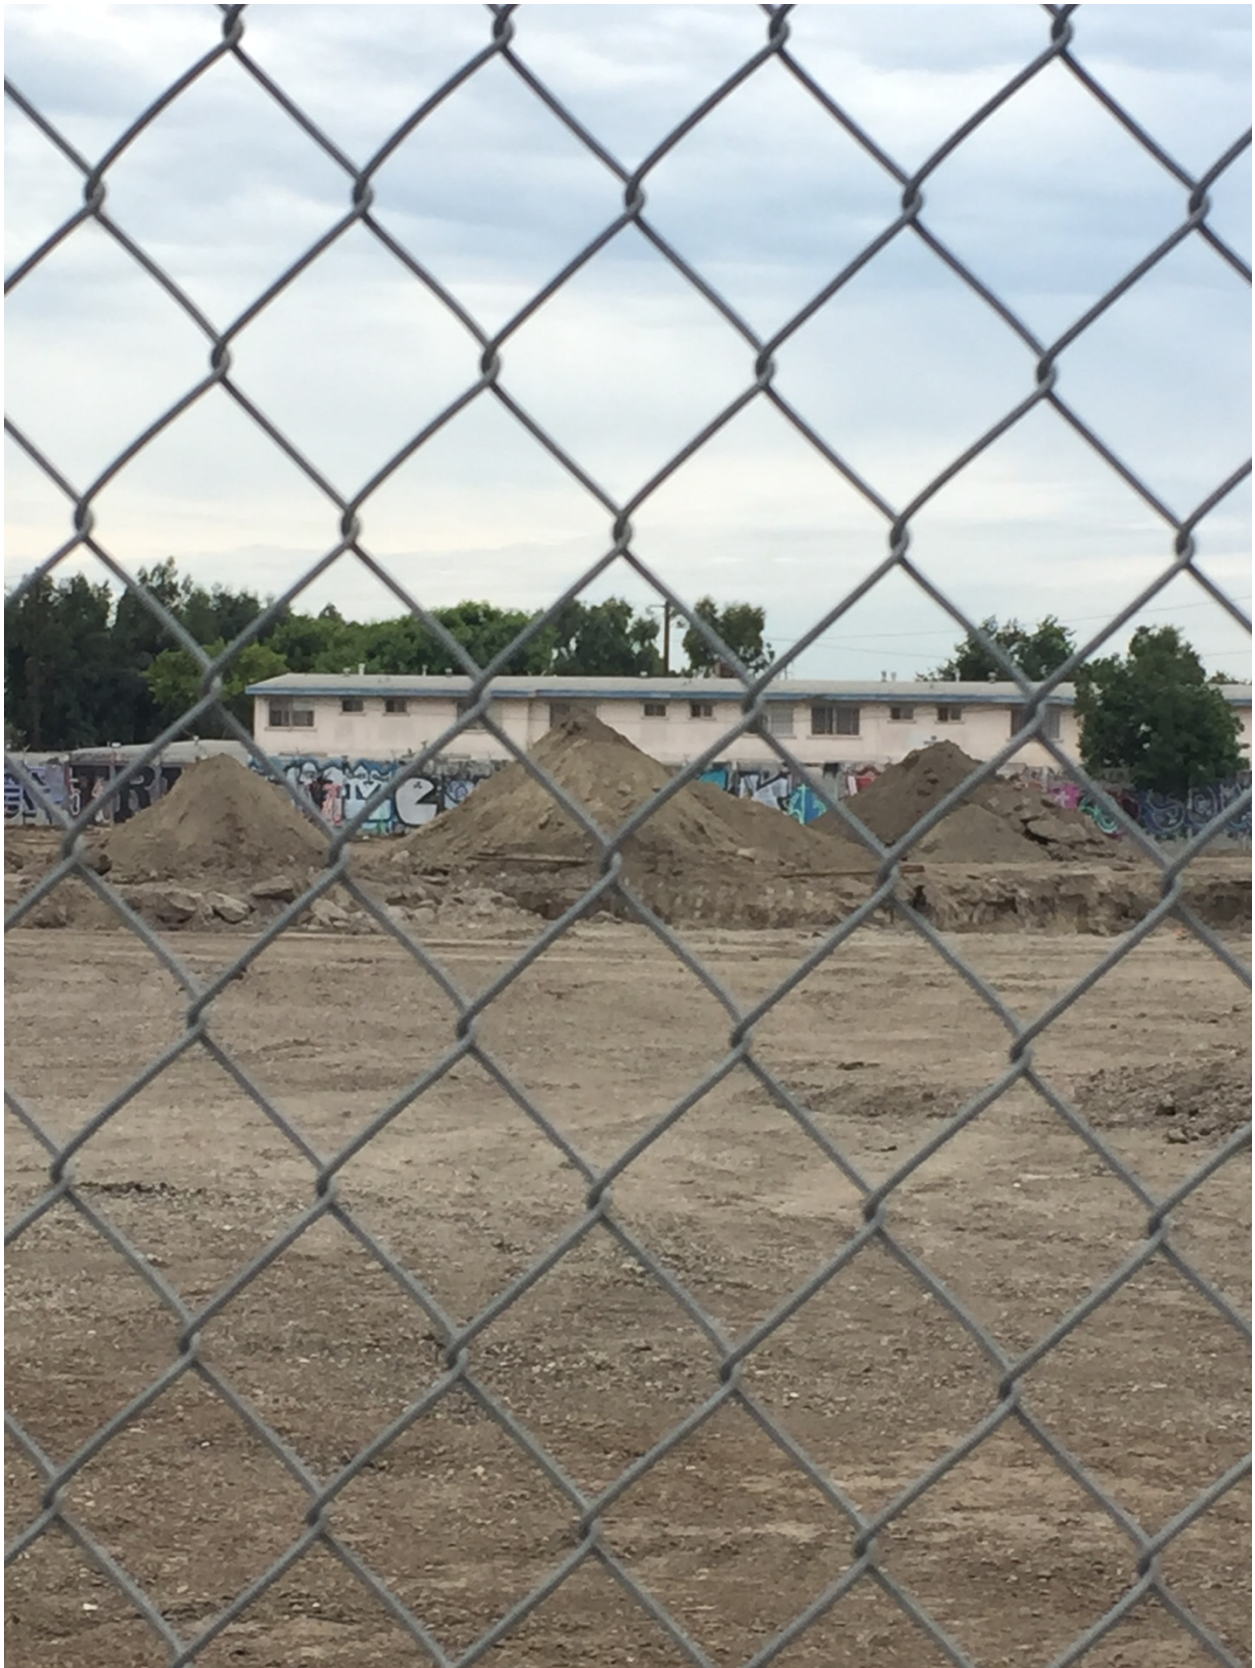
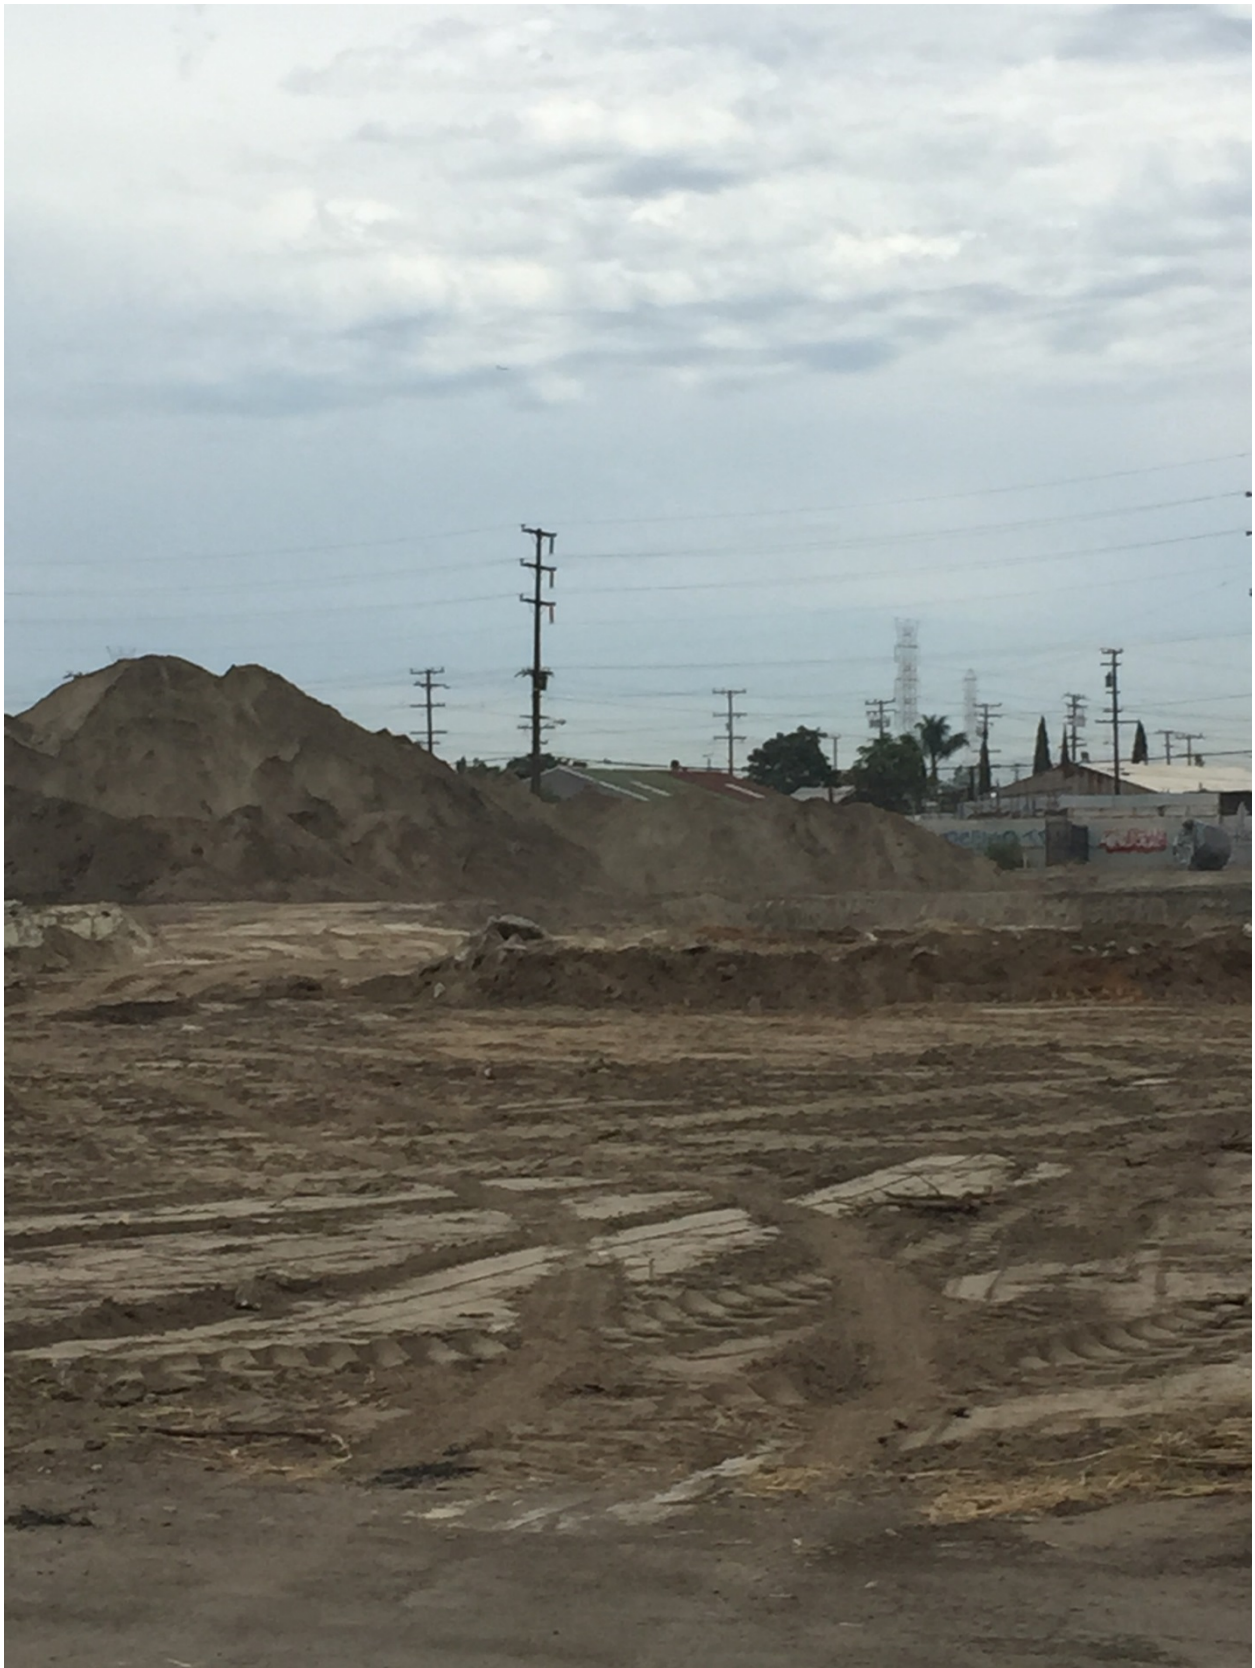
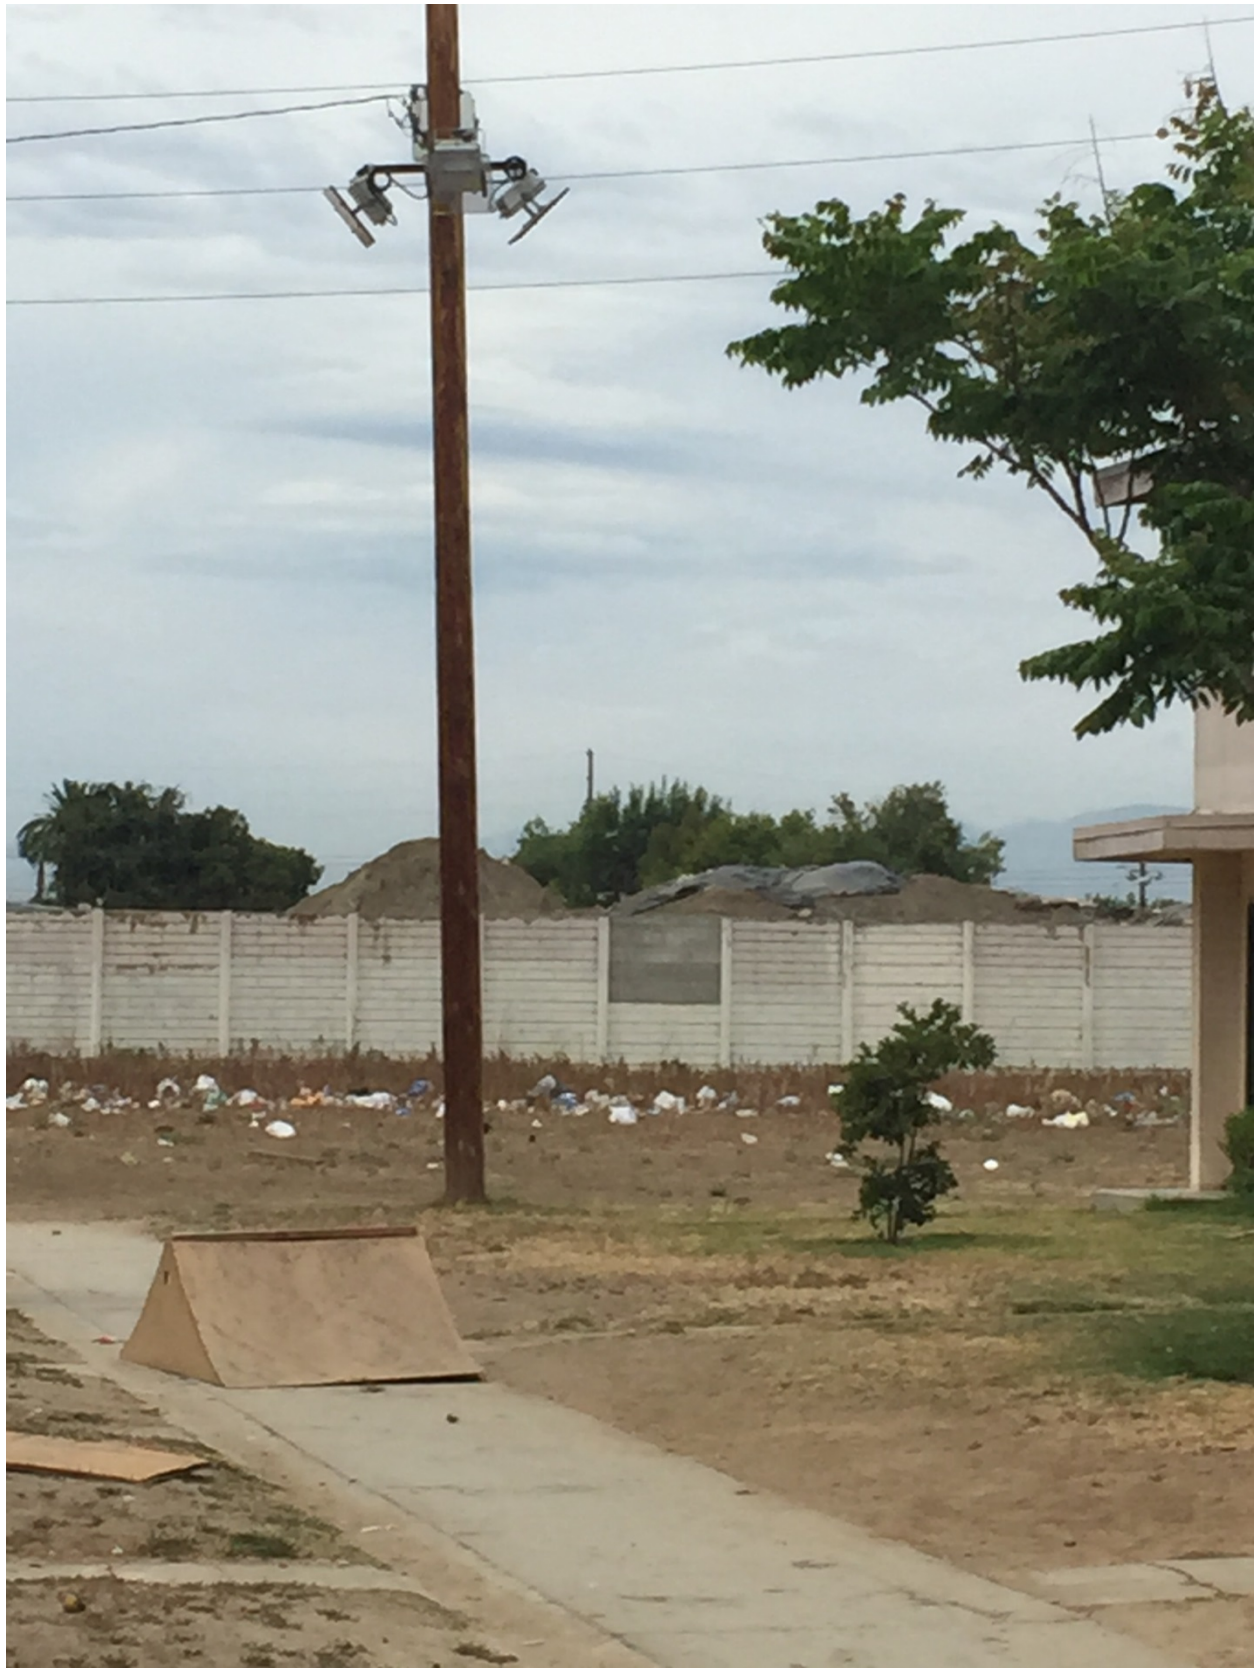
EXHIBIT 6

I could observe many extremely large stockpiles of soil at the Site which appeared much higher than the cinderblock wall. The majority of these were uncovered, though I did see two or three which were partially covered in a tattered material, but none were entirely covered to control for dust. When I proceeded to the other side of Jordan Downs, to the buildings on the southern side of the work site, I observed similar conditions, with large mounds of soil visible above the wall.

Follow-up conversations with various residents have confirmed that dust entering the residences is a pervasive and ongoing problem. Residents have further reported that stockpiles of excavated material remain uncovered over weekends and during non-work hours, including during the recent rainstorm which occurred on July 19th, 2015.

VARIOUS UNCOVERED STOCKPILES OF EXCAVATED MATERIAL

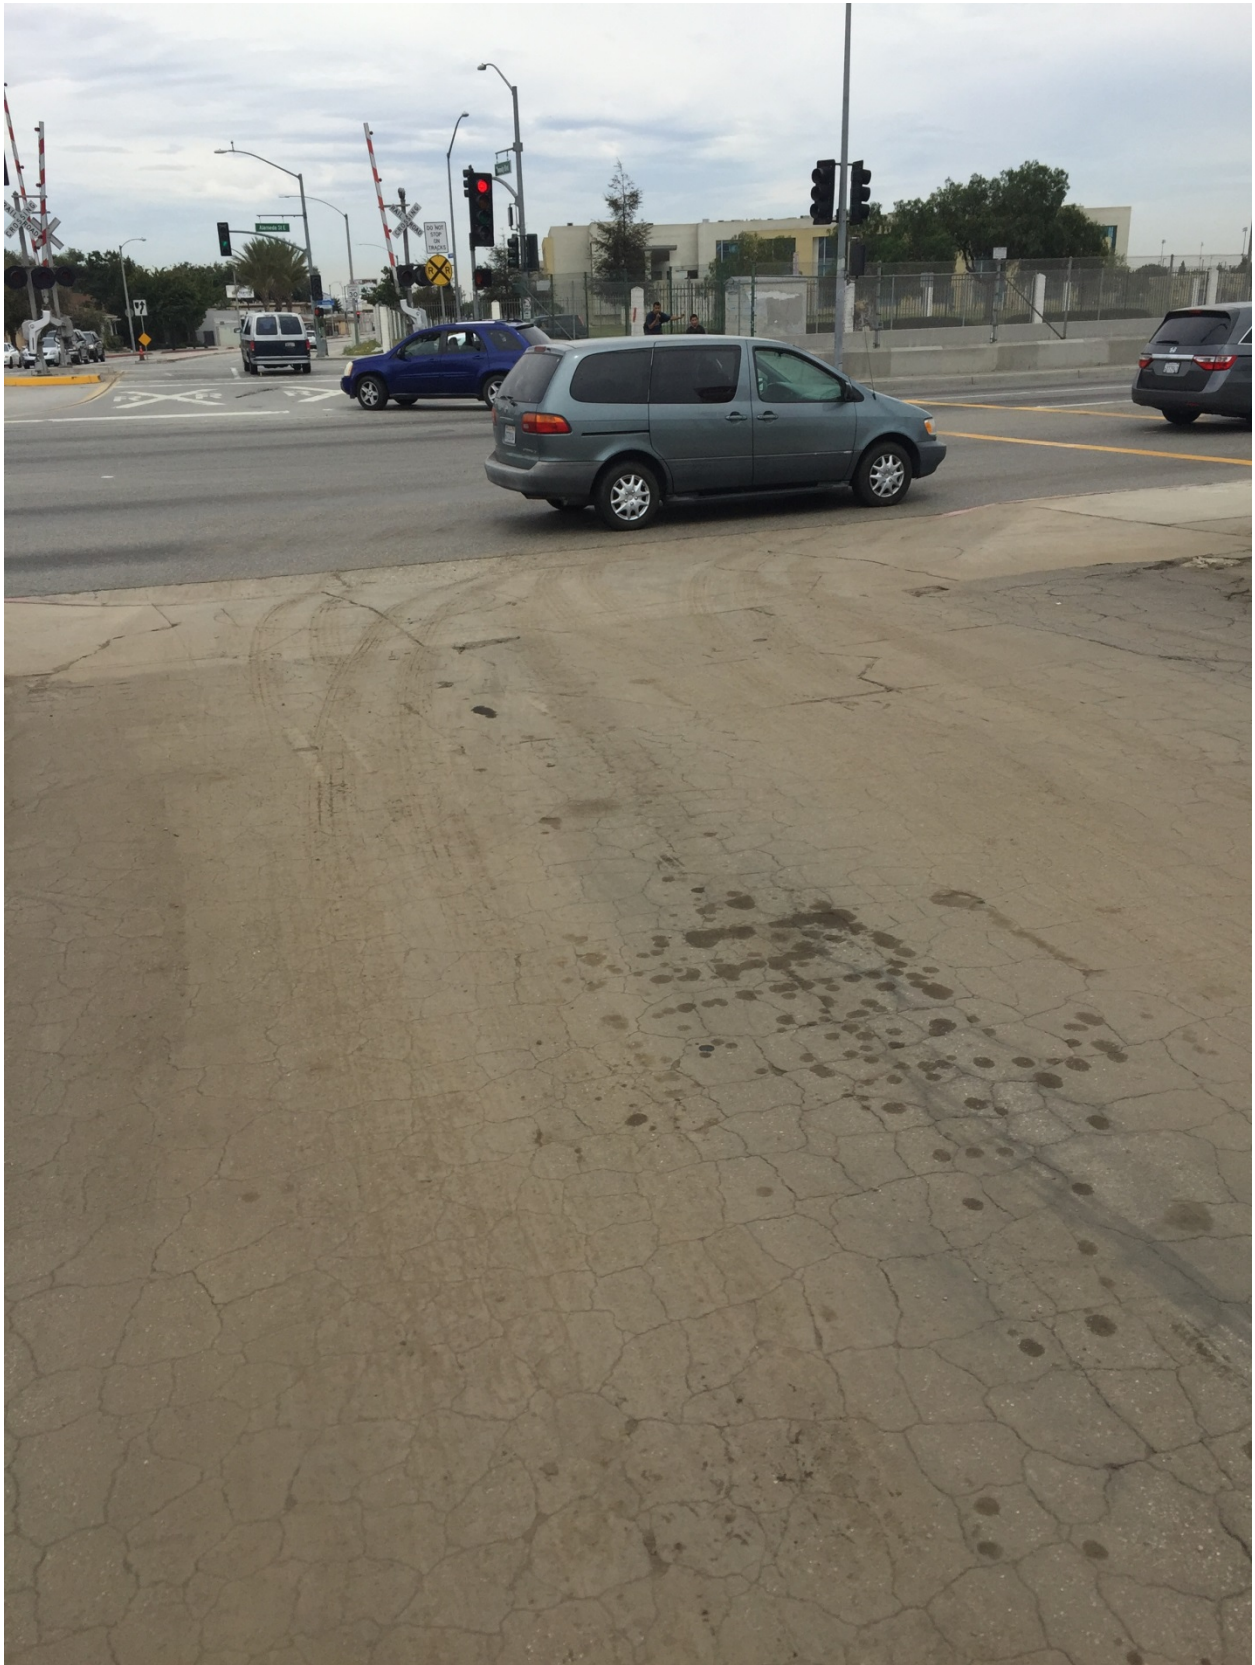
EXHIBIT 7

The IRAP requires that measures be put in place to prevent the possibility of excavated material embedded in truck wheels to migrate off-site, including “wheel shakers” and wheel washing. *Final IRAP Health and Safety Plan §8.0, at 15; Final IRAP Traffic and Transportation Plan §4.1, at 4.* While I did observe a “wheel shaker” in place at the Site entrance on Alameda Street, it was clearly insufficient to satisfy the requirements of the IRAP, as there were visible tracks of dirt leading onto the public roadway away from the Site. I did not observe any type of wheel washing system in use. *See Exhibit 7.*

**VISIBLE TRACKS OF EXCAVATED MATERIAL ON PUBLIC ROADWAY LEADING
AWAY FROM SITE**

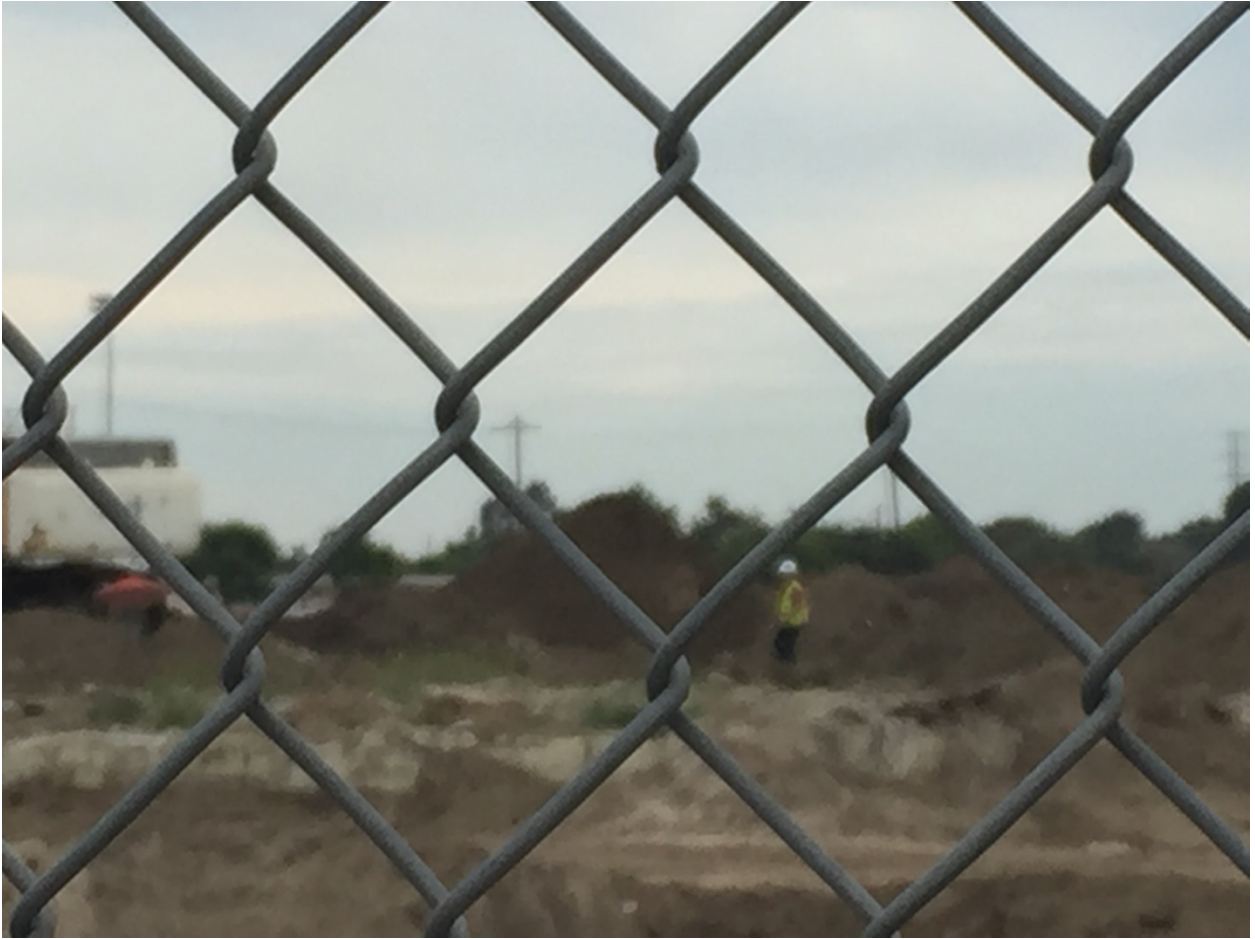
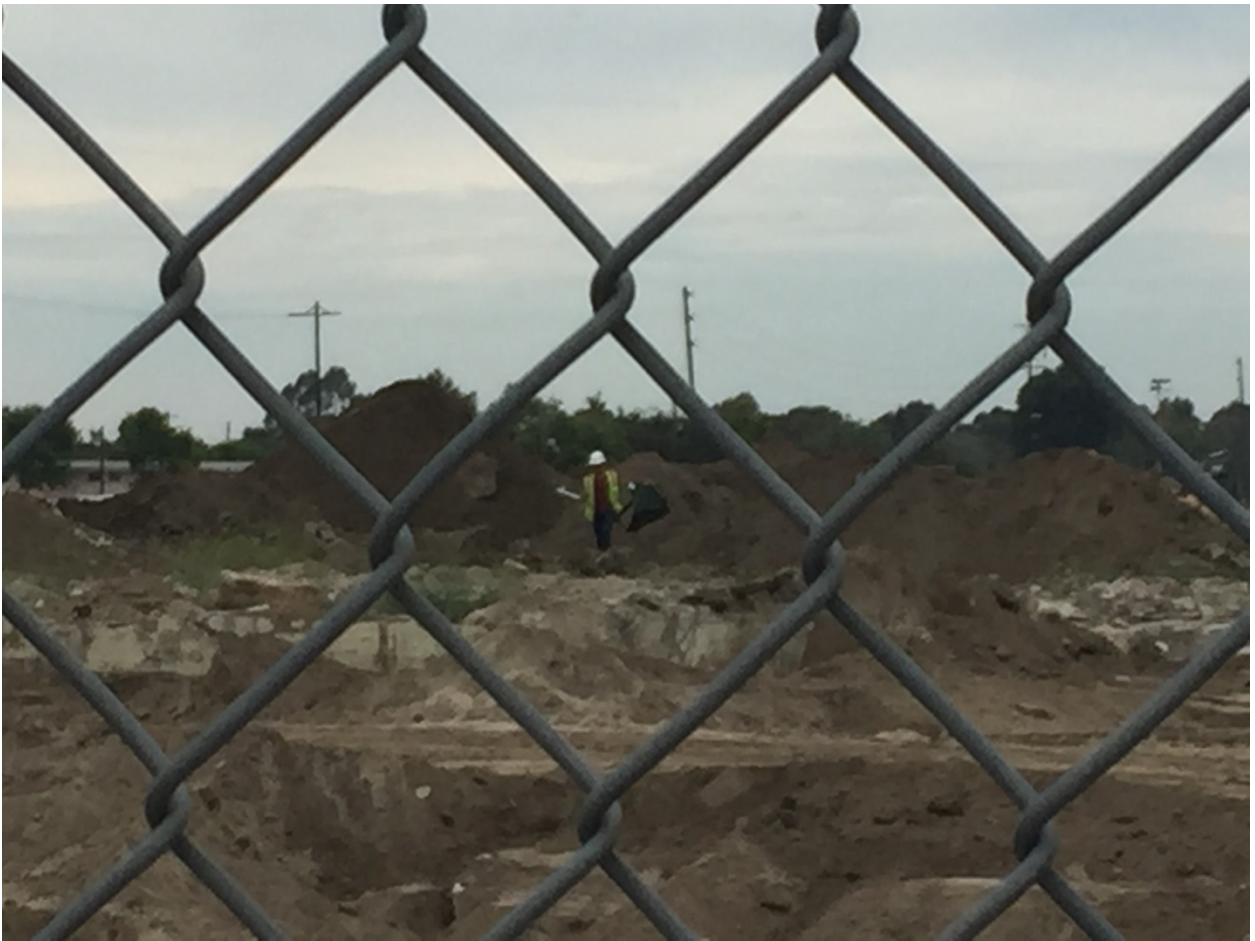
EXHIBIT 8

The IRAP’s Health and Safety Plan governs the requirements for worker safety during the remediation, including the requirements for the use of Personal Protective Equipment (PPE). Among the PPE required to be used during the remediation of the Site are coveralls and disposable gloves to prevent workers from coming into contact with contaminated soils. *Final IRAP Health and Safety Plan, § 5.0, at 10.* Soil excavation/removal work was active at the time I arrived at the Site, but workers did not appear (from the entrance to the project site) to be wearing any personal protective equipment except orange safety vests and hard hats. I did not observe any workers wearing coveralls

or gloves, and saw multiple workers in short-sleeved shirts climbing or walking on large piles of dirt which had been excavated. Dust masks were not being utilized. *See Exhibit 8.*

WORKERS EXPOSED TO EXCAVATED MATERIAL WITHOUT PERSONAL
PROTECTIVE EQUIPMENT
